School of Civil Engineering, Purdue University, 550 Stadium Mall Dr., West Lafayette, 47907 IN, U.S.A

## PREMATURE DETERIORATION OF JOINTS IN SELECTED INDIANA PORTLAND CEMENT CONCRETE PAVEMENTS

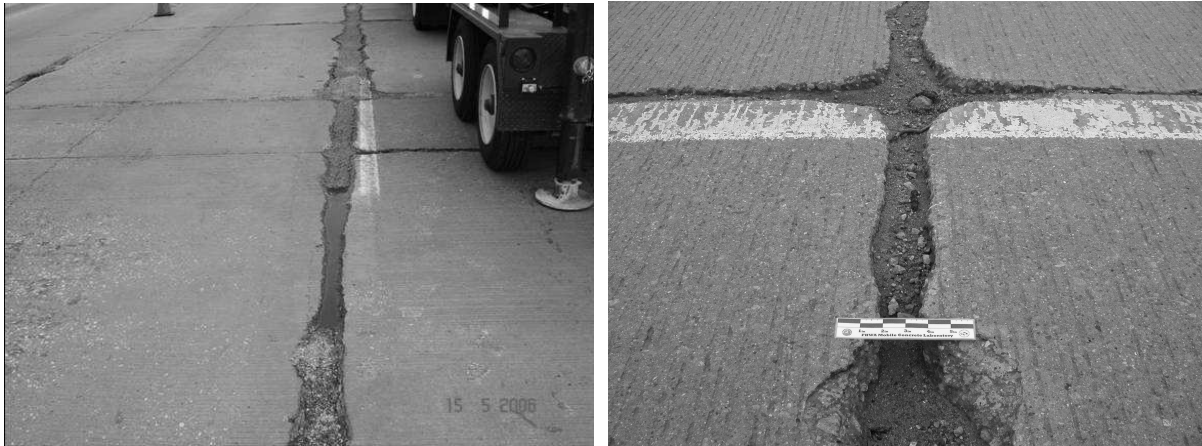
Some of the 5-10 years-old concrete pavements located in various part of Indiana, USA, that otherwise perform well, show signs of premature deterioration (in the form of excessive cracking and spalling) primarily in areas near the longitudinal joints; in several cases, the transverse joints areas have been affected as well. The deterioration has been observed (among others) at SR 933 near South Bend, on some sections of I-65, as well as on several roads in the Indianapolis area

Fig. 1. Section of pavement on W 86<sup>th</sup> Street, Indianapolis, IN (left) and SR 933 near South Bend, IN (right)

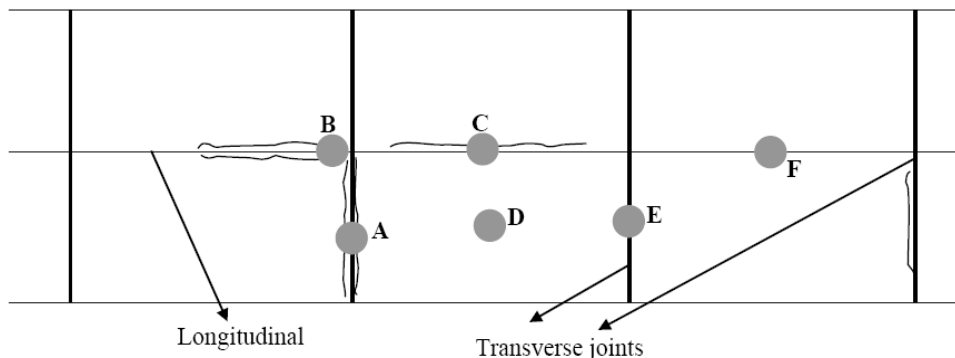
When selecting the coring locations on the ramp from US 67 to eastbound I-465E and on W 86<sup>th</sup> Street an attempt was made to obtain specimens for various cases presented in Figure 2 and listed below:

A – damaged area of the transverse joint

B – damaged area of the longitudinal joint near the junction of the longitudinal and transverse joints

C – damaged area of the longitudinal joint away from the transverse joint

D – mid-span of the slab, undamaged section

E – undamaged transverse joint adjacent to the damaged transverse joint

Fig. 2. Proposed coring locations

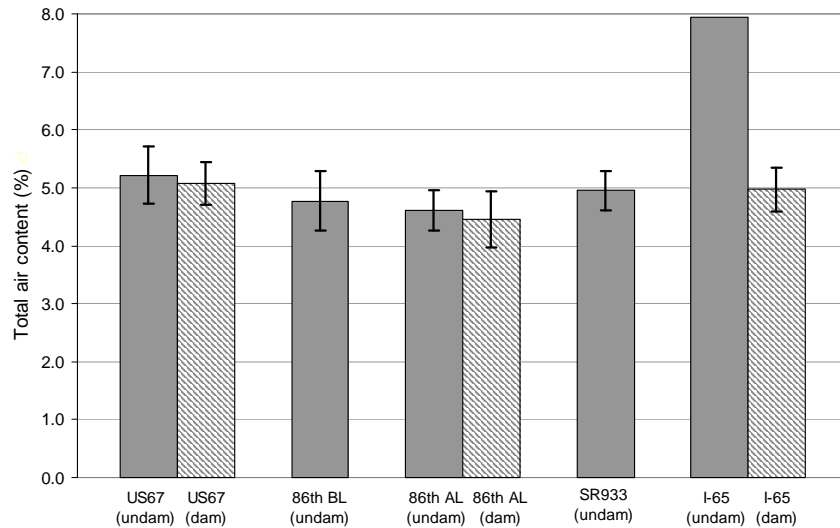
Fig. 4. Average total air content for undamaged (undam) and damaged (dam) cores from each location

Figure 4 reveals that, with the exception of core 6F from I-65, the average total air content of both damaged and undamaged cores was almost the same (~5.0%). Similarly, with the same exception, no significant differences in the average amount of entrained air content were present between the undamaged and damaged cores (Fig. 5). However, as seen in Figure 6, the average values of the void frequency for all undamaged cores were higher than those in the damaged cores, indicating that the specific surface area of the air-bubbles system in these cores is high (see Table 2) and thus offers good frost-resistance potential. Particularly high average void

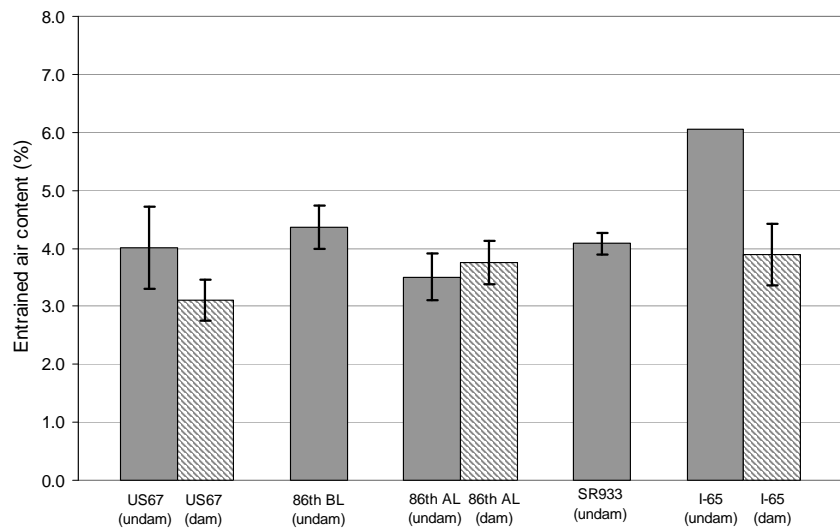
Fig. 5. Average entrained air content for undamaged (undam) and damaged (dam) cores from each location

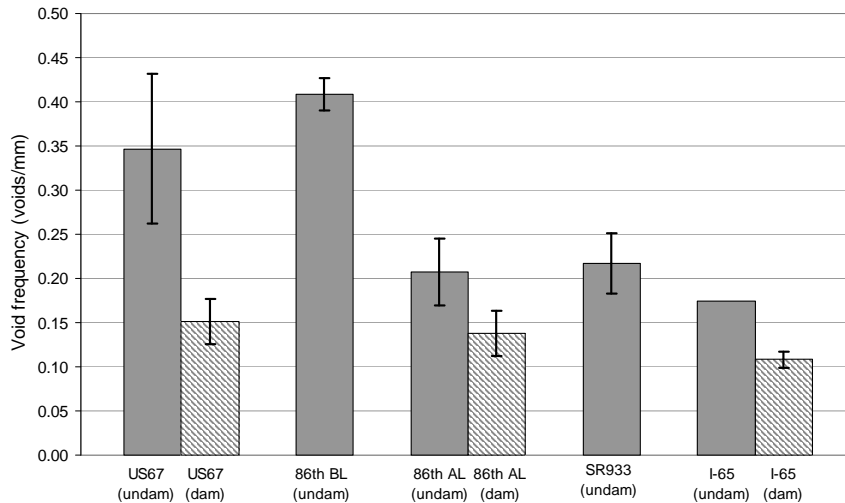
frequencies were found for undamaged cores from US 67 (0.35 voids/mm) and W 86<sup>th</sup> Street BL (0.41 voids/mm). Similarly, as shown in Figure 7, the average values of spacing factor in the undamaged cores was always lower than that in the damaged cores, again indicating potential for better freeze-thaw resistance of the former.

Fig. 6. Average void frequency for undamaged (undam) and damaged (dam) cores from each location

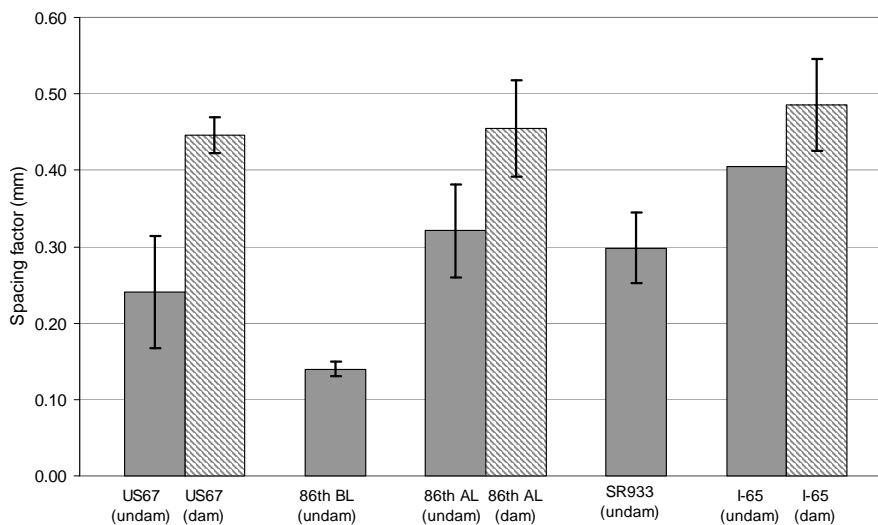
Fig. 7. Average spacing factor for undamaged (undam) and damaged (dam) cores from each location

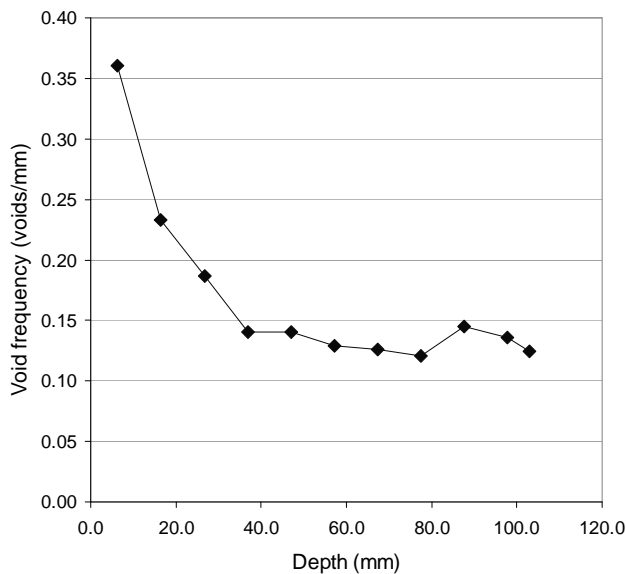
Two other important features were observed during the air-void system analysis. First, the descending trend in void frequency with depth was found for the total of 12 specimens from all locations (see Table 2). The example of this trend is presented in Figure 8. It is clear that within about 25 mm from the surface of the core the void frequency was two to three times higher than that observed in the lower section of the specimen.

Fig. 8. Void frequency vs. depth for US 67 core #1A

The reason for the discrepancy in the amount of air (as represented by void frequency) between the upper and lower parts of the ASTM C 457 specimens (shown in Fig 8) may be explained by the presence of the sealing material in the upper part of the joint. This material, by adhering to the walls of the joint, might have blocked the ingress of water to the interior of

concrete near the top part of the joint, thus preventing precipitation of deleterious products and in-filling of the air voids. At the same time, relatively poor air void-system parameters found in most of the cores in which the joints sealer has been lost (US 67 and W 86<sup>th</sup> Street AL cores) can be attributed to the fact that their air voids were progressively filled with precipitates, and thus become ineffective. This observation implies that the “original” parameters of the air-void system could have been well within the expected limits, but become compromised over time, perhaps because of poor drainage, locking-up of joints, water ponding, etc.

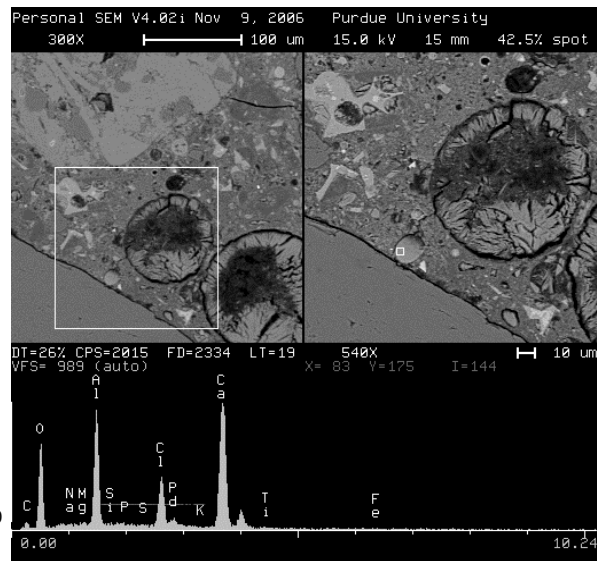
Fig. 9. Air-voids filled with ettringite and Friedel's salt present in core I-65\_3B

Second, in all but three of the specimens displaying this trend numerous in-filled voids were found (Table 2). The voids were filled with either ettringite ( $3\text{CaO}\cdot\text{Al}_2\text{O}_3\cdot 3\text{CaSO}_4\cdot 32\text{H}_2\text{O}$ ) or (occasionally) with Friedel's salt ( $\text{Ca}_3\text{Al}_2\text{O}_6\cdot\text{CaCl}_2\cdot 10\text{H}_2\text{O}$ ) as seen in Figure 9. In their paper on delayed ettringite formation (DEF) Stark and Bollmann [4] suggested a change in thermodynamic stability of monosulfate at low temperatures that leads to formation of ettringite (through partial decomposition of monosulfate). They also found that freeze-thaw cycling in 3 % NaCl solution resulted in transformation of monosulfate to Friedel's salt and ettringite.

Different from the discussed above is the case of I-65 cores for which the microstructural analysis using optical microscope did not reveal the presence of the in-filled air voids. This observation has initially led the authors to believe that this concrete must have had poor quality air-void system at the time of placement. However, subsequent analysis of the same specimens performed using the scanning electron microscope (SEM) indicated that substantial amount of air voids were in fact in-filled (Fig. 9). The reason that these voids might have not been visible under optical microscope was related to excessive content of sulfate in the entire matrix. The uniformly distributed sulfate phase reduced the contrast between the in-filled voids and surrounding paste, thus making the in-filled voids more difficult to detect.

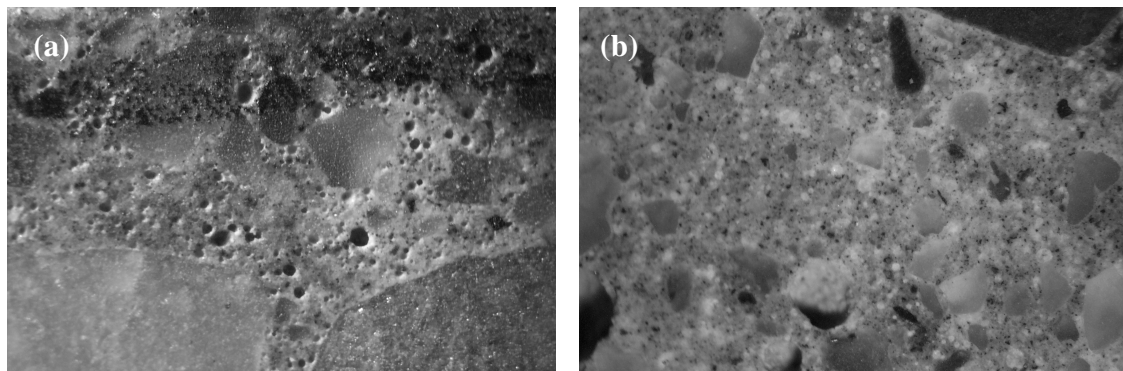
As an example, Figure 10(a) shows the typical appearance of empty air voids in the upper section of the ASTM C 457 specimen obtained from core #1A from US 67, whereas Figure 10(b) illustrates completely in-filled air voids observed in the lower section of the same specimen (about 25 mm below the top).

Fig. 3. Empty air voids in the top portion (a) and in-filled air voids in the bottom portion (b) of ASTM C 457 specimen obtained from core #1A from US 67 ramp
