**XXIV**XXIV Konferencja Naukowo-Techniczna
Szczecin-Międzyzdroje, 26-29 maja 2009**awarie budowlane**Prof. GARY T. FRY, garyfry@tamu.edu

FATIGUE CRACKS IN DAPPED STEEL HIGHWAY BRIDGE GIRDERS

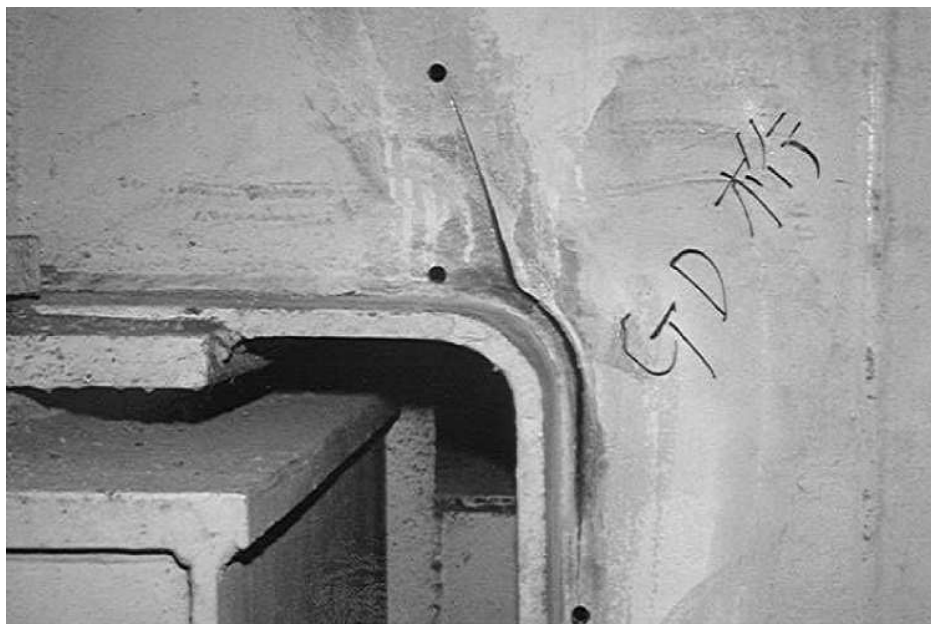
In Japan a dapped girder is usually referred to as a “cut-off” girder. Since the early 1960 s, dapped steel girders have been used widely in Japan; a common application has been a 90-degree rounded detail. Figure 2 is a photograph of a typical Japanese 90-degree rounded dap detail that has developed fatigue cracks. The photograph was taken in 1979 after the girder had been in service for approximately 15 to 20 years.

Figure 2. Fatigue Cracks in 90-Degree Rounded Detail in Japan

The holes visible at the ends of the fatigue cracks were drilled to inhibit further propagation of the cracks. This type of cracking behavior is typical. Generally, the cracks initiate at either the root or the toe of a fillet weld where the weld joins the web plate to the curved portion of the bent flange plate. The cracks then propagate within the web vertically and also within the web around the bent flange. The flange plate itself remains completely undamaged. Since the mid -1970 s, hundreds of instances of fatigue cracking have been reported in Japan involving this detail.

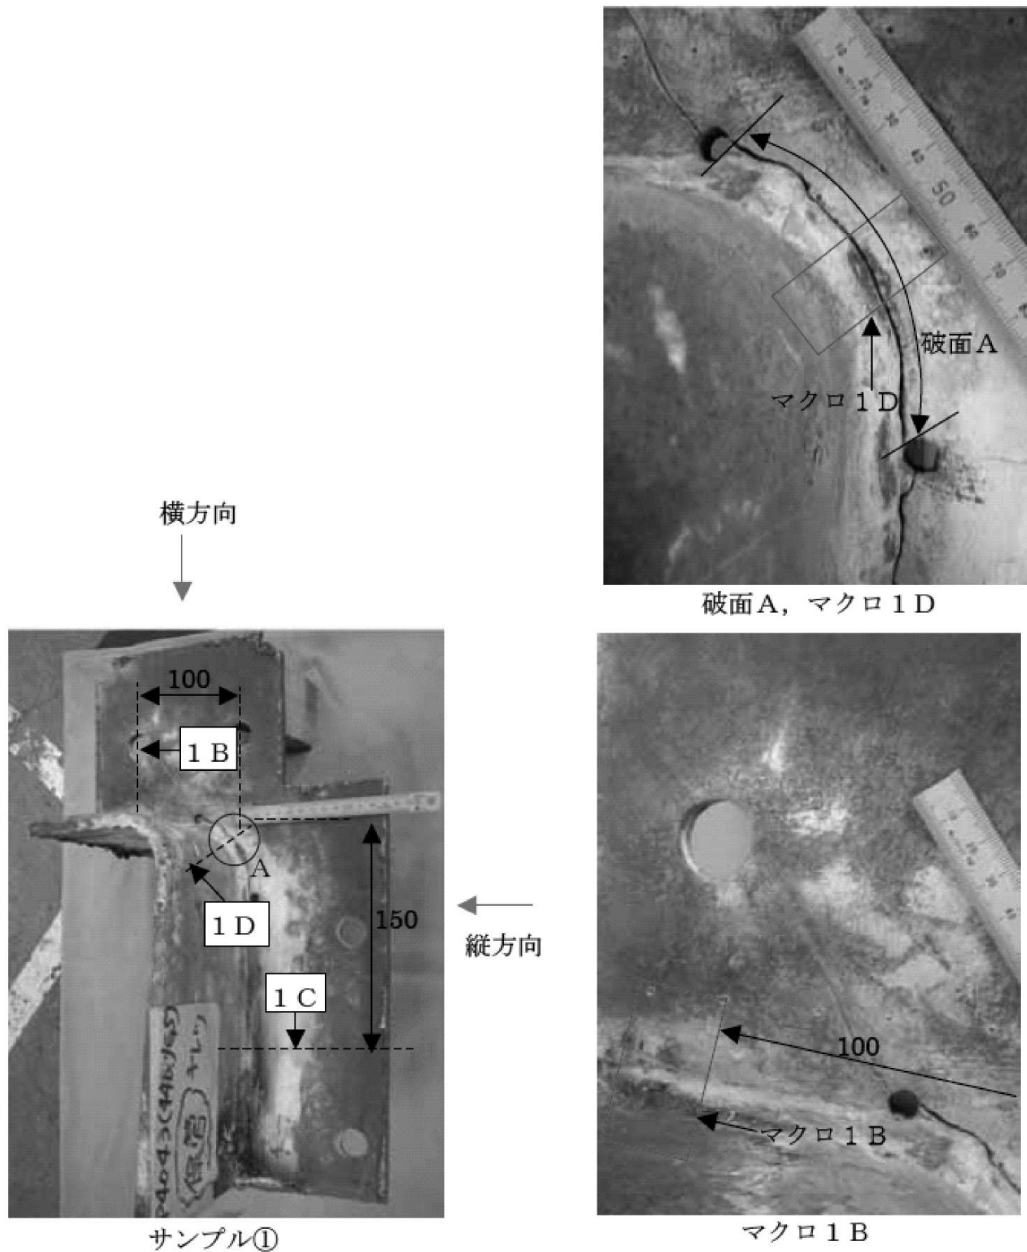
Figures 3 and 4 are photographs of a macroscopic specimen taken from a damaged 90-degree rounded detail. The cracking observed in this specimen is similar to that seen in Figure 2, though the specimen is not taken from that beam.

Figure 3. Macroscopic Specimen from 90-Degree Rounded Detail with Fatigue Cracks

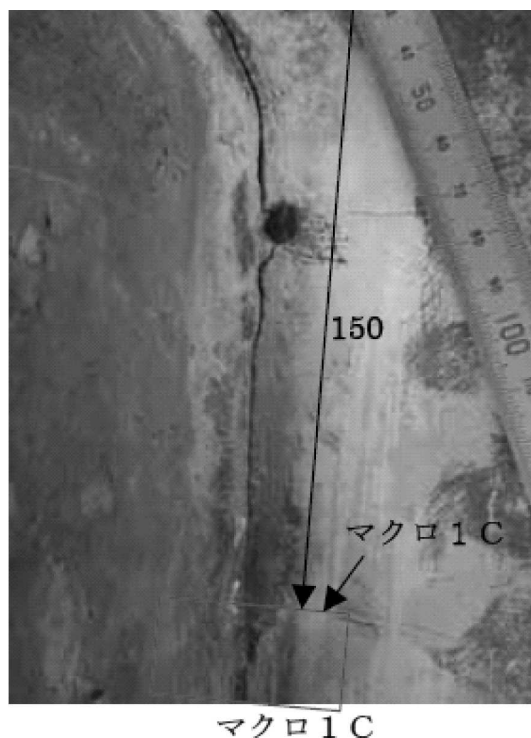
Figure 4. Closeup View of Area 1-C in Macroscopic Specimen

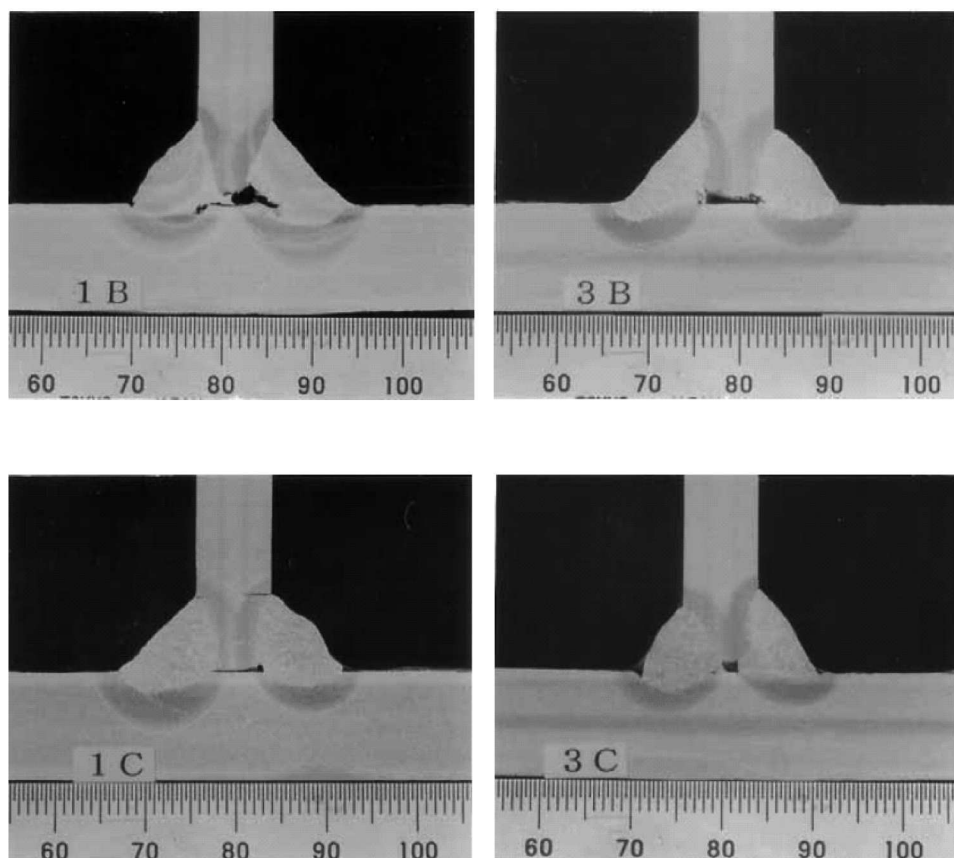
seen in the bottom left of Figure 5, a fatigue crack is visible at the toe of the right-hand-side fillet weld. At section 1-D, seen in Figure 6, the crack has completely severed the web plate. At section 3-D, seen in Figure 6, another toe crack is visible.

Figure 5. Photomicrographs of Etched Samples 1 and 3 (1-B, 1-C, 3-B, and 3-C)

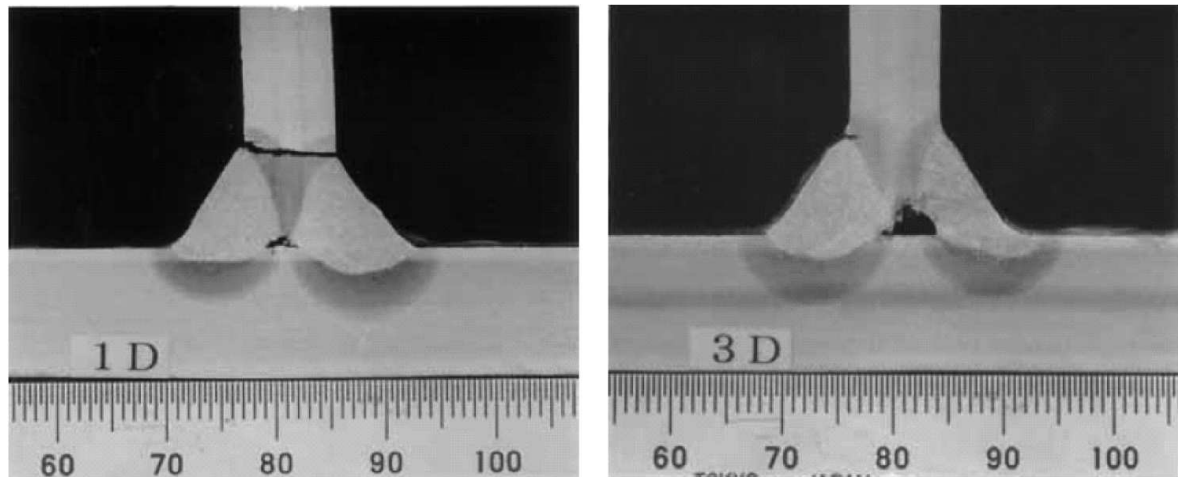
Figure 6. Photomacrographs of Etched Samples 1 and 3 (1-D and 3-D)

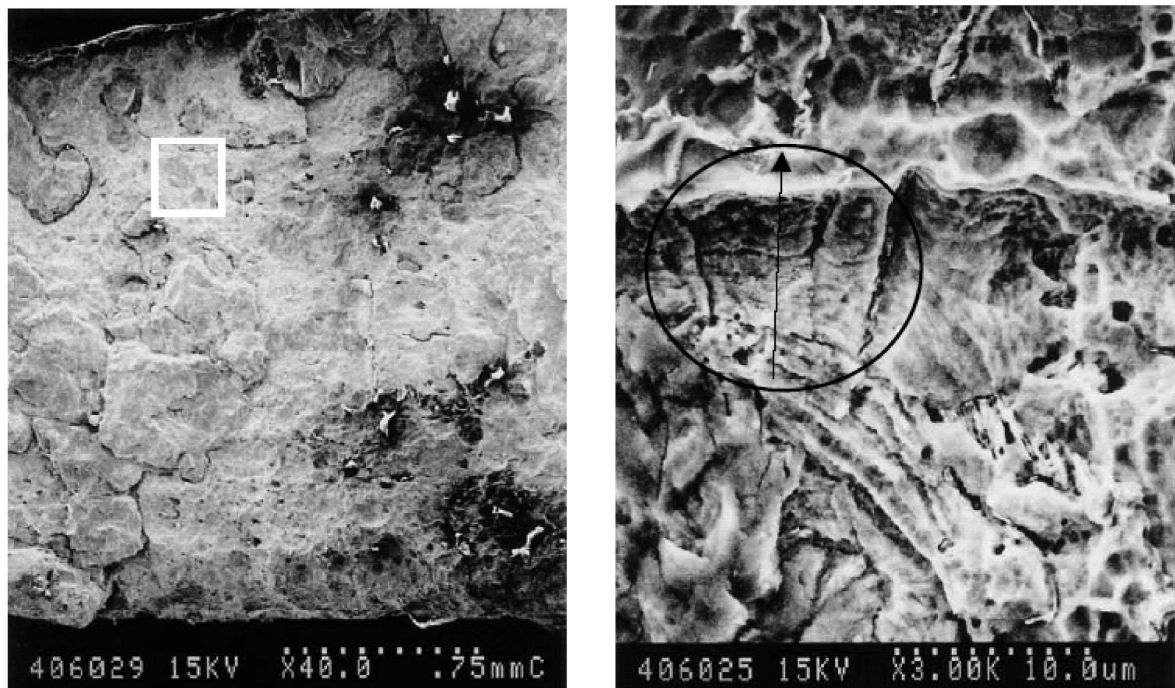
Figure 7 is a scanning electron microscope image of the crack initiation site on the fracture surface. The direction of crack propagation is indicated by an arrow in the image on the right-hand side of Figure 7.

Figure 7. Scanning Electron Microscope Image of Fracture Surface.

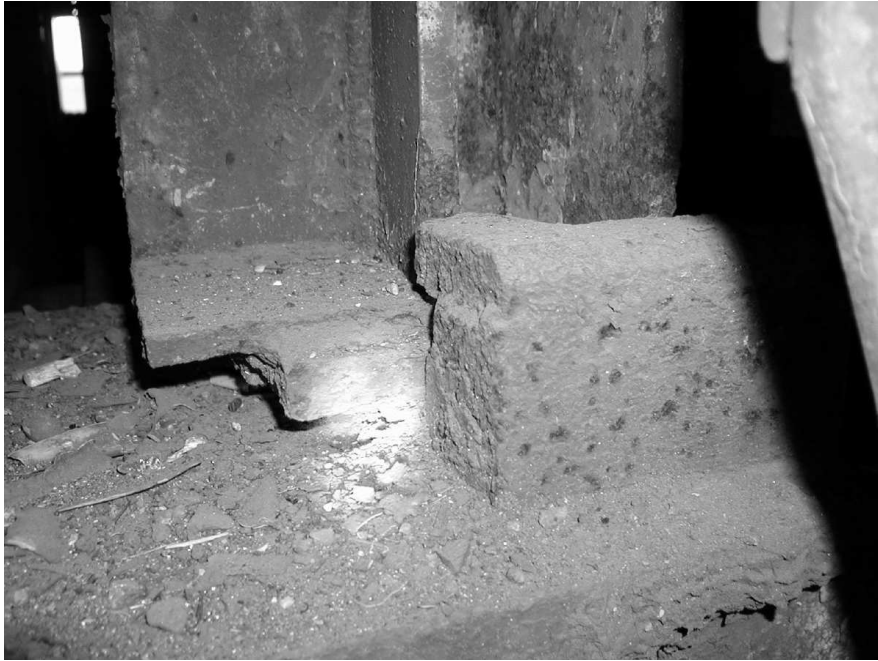
Following the initial discovery of the cracks, analytical and experimental studies, including field tests, were conducted to determine the essential causes of the cracking. A recent summary of several fatigue applications in Japanese steel bridges is available in English (Pengphon et al. 2004). The studies suggested four potential contributing factors including the following: fabrication errors; interruption of the natural flow of stresses because of the 90 degree bend, thereby causing an unanticipated stress concentration; local out-of-plane distortions of the beam web; and inadequate rotation capacity of the beam seats because of corrosion (see Figure 8).

Figure 8. Corrosion of Beam Seat

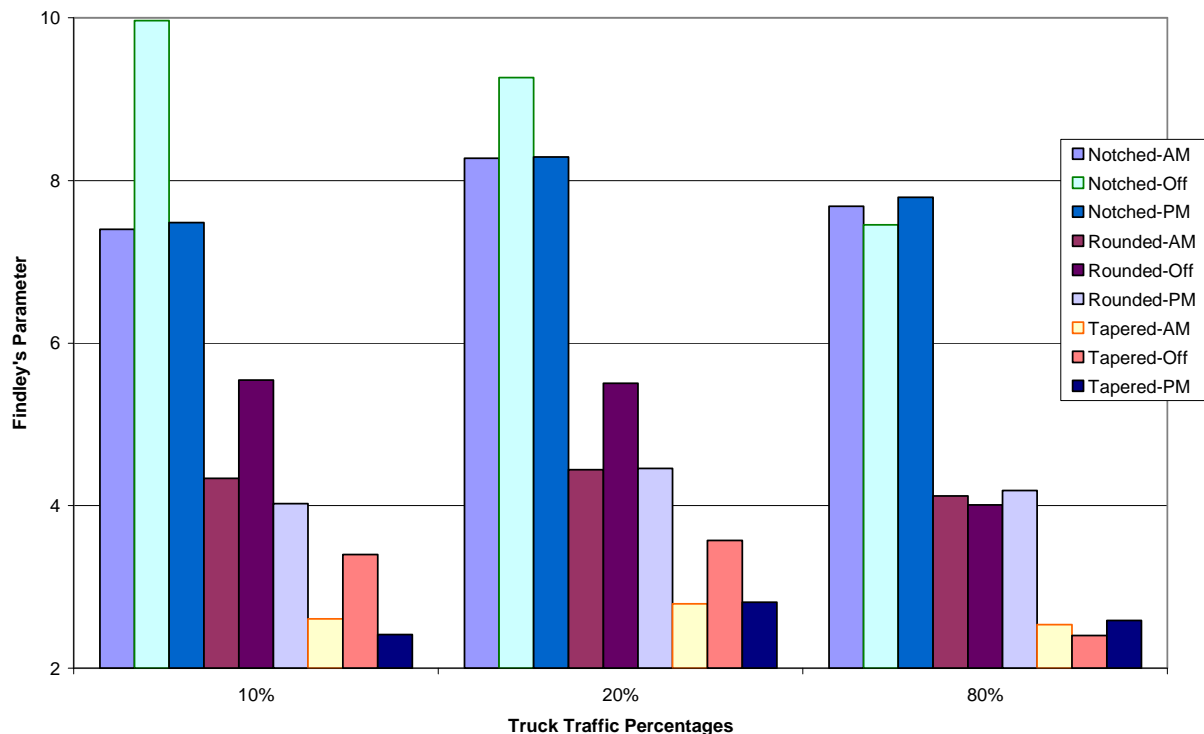
Figures 9 and 10 show that the notched detail experienced the highest values for Findley's parameter and the tapered detail experienced the smallest values. As mentioned before, these values are inversely correlated with fatigue life; higher values indicated shorter lives. It is also interesting to note that the Findley's parameters for the tapered detail were lower than those of the rounded detail. This is a consequence of the way in which Findley's parameter is calculated. A large variation of shear stress on a critical plane causes more fatigue damage than a high mean stress level that does not fluctuate. This fact seems to imply that the rounded girder would have more fatigue problems than a tapered girder.

Figure 9. Fatigue Analysis Results for CORSIM Traffic Correlated to Link 13

For link 13, as shown in Figure 9, with 10 or 20 percent truck traffic, the off-peak period had substantially higher Findley's parameters for all details. This observation acknowledges the more damaging effect of a lighter volume of traffic with its associated larger range of

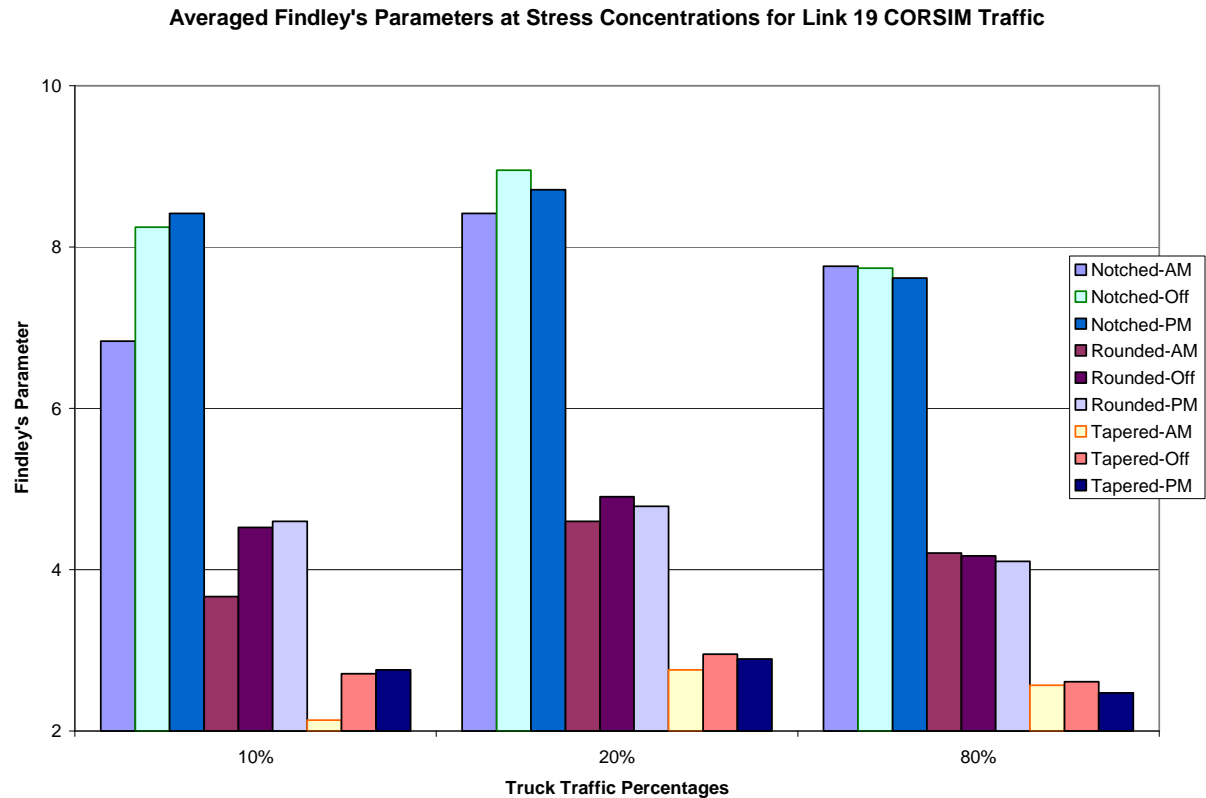
Figure 10. Fatigue Analysis Results for CORSIM Traffic Correlated to Link 19

This loading has the effect of “balancing” the stresses and creating a lower overall stress-range condition. Higher loading on one span corresponds to the analogy of loading alternate spans. In a lower volume link, with fewer trucks, and in an off-peak period, the chances of having a large difference in span loading are much greater. This phenomenon seems to be verified by Figure 10. Link 19 is a higher volume link, and Findley’s parameters for the details are very similar regardless of peak period or truck traffic percentages.

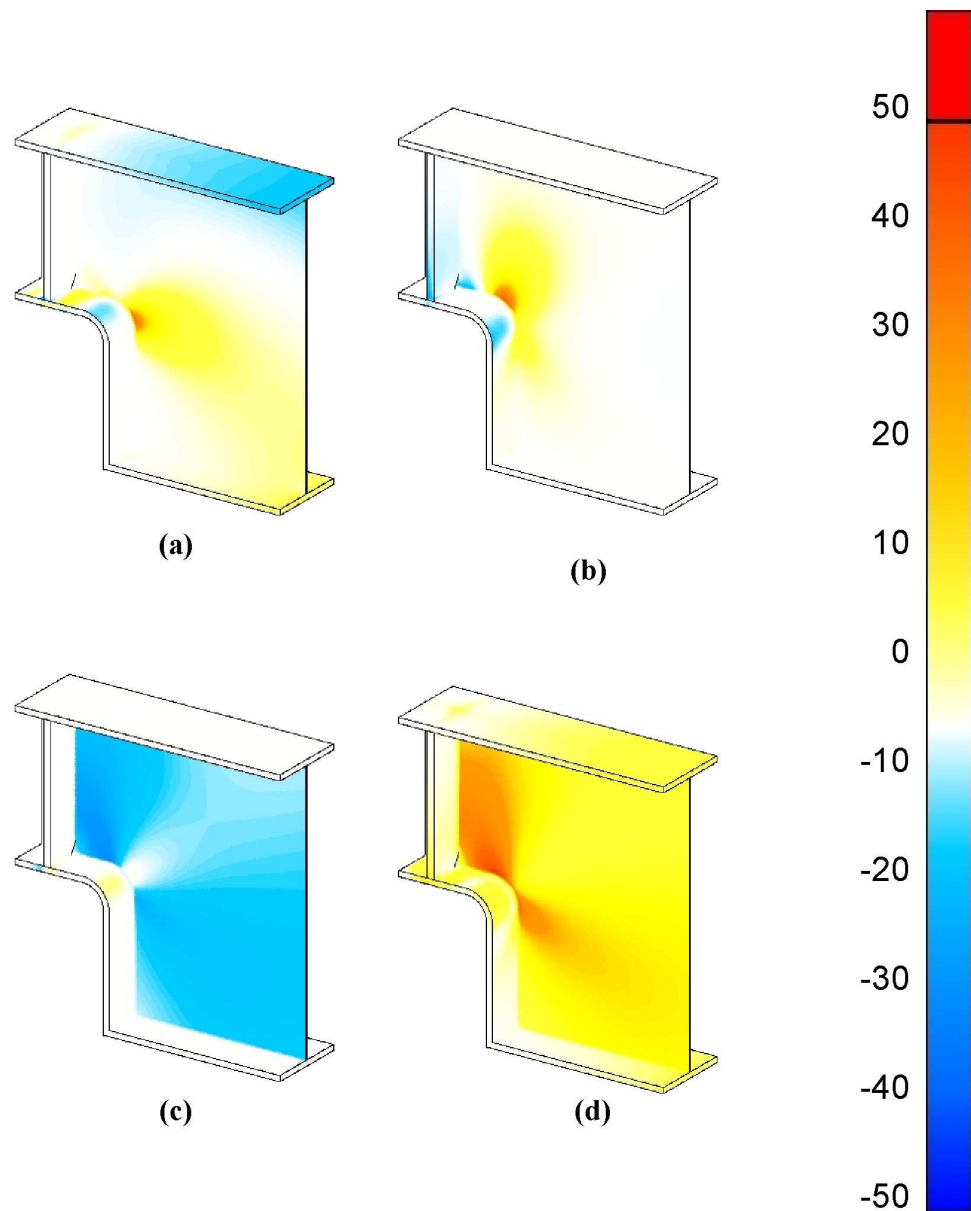
Finally, Figure 11 shows stress fringe plots from a static analysis of a rounded detail similar to that used in Japan. It is clear that the regions in which the fatigue cracks were observed to initiate experience a marked concentration of stress.

Figure 11. Stress Contour Plots of 0.5-in. Thick Web Local Models for Round Girder with No Stiffeners at Ultimate Load Capacity. (a) σ_{xx} , (b) σ_{yy} , (c) τ_{xy} , (d) von Mises Stress.
