JOHN M. KULICKI
Chairman/CEO
Modjeski and Masters, Inc.
Mechanicsburg, PA USA

LEARNING FROM FAILURES AND MISTAKES – THEIR INFLUENCE ON U.S. BRIDGE CODES AND PRACTICE

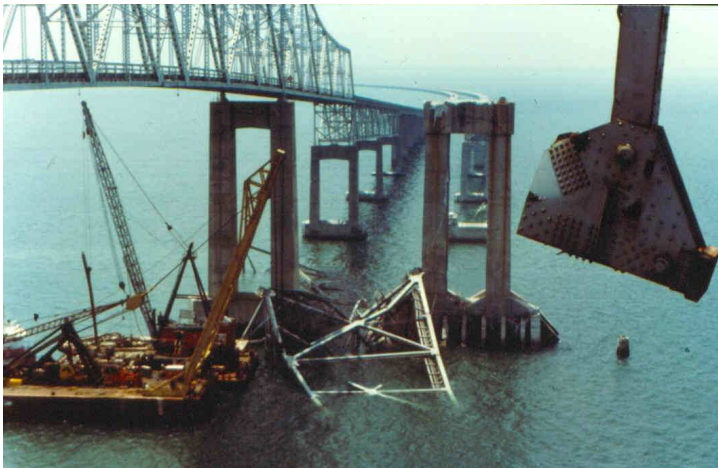
In 1980, the Motor Vessel Summit Venture hit a side span pier of one of the parallel cantilever trusses forming the Sunshine Skyway in Tampa Bay in the state of Florida with the result shown in Fig. 1. These particular piers were not protected from vessel collision. The response to this collapse, which resulted in numerous deaths, was a research project leading to the 1994 publication of a Guide Specification for Vessel Collision [3]. The principles in this document were incorporated into the First Edition of the AASHTO LRFD Bridge Design Specifications (AASHTO LRFD) in 1993. The design process has been updated and the specifications adjusted accordingly when the Guide Specification was republished in 2008. Various investigators contributed to expanding the knowledge base regarding vessel collision [4, 5].

Fig. 1. View of Skyway Collapse (Courtesy of Donald F. Sorgenfrei)

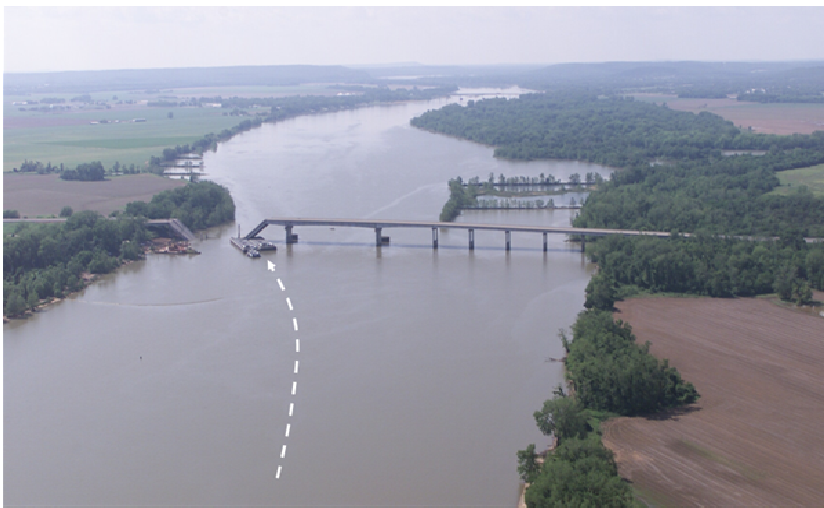
Human factors and random events had a great deal to do with the vessel collision with the bridge near Webber Falls, Oklahoma, shown in Figs. 2, 3 and 4. In this particular incident, several barges and a tug boat appeared to be traveling in a transit line which was oriented towards going through the protected navigation span. It appears that the pilot lost control of the tug and it took the path shown by the dotted line in Fig. 2, resulting in collapse of a pier shown in Figs. 3 and 4. Several vehicles vaulted through the opening resulting in numerous deaths.

Fig. 2. Apparent Path of Aberrant Barge Tow at Webber Falls (Source: Oklahoma DOT)

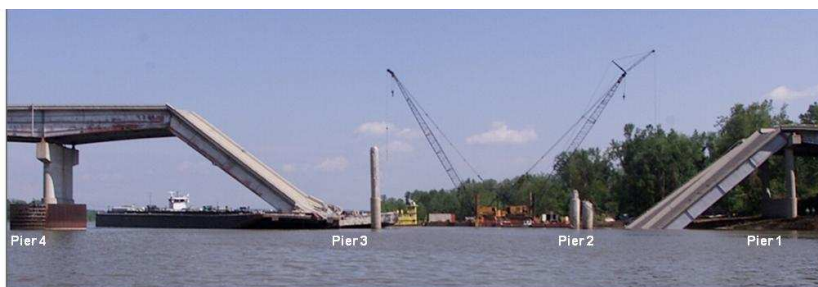
- The barge that impacted the pier column was reversed in its position such that the stronger stern hit the pier and exerted more load than if the barge had been properly positioned and the bow struck the pier.
- The impact involved the corner of the barge which had less energy absorption capability than if the impact had been with the frangible center of the barge.
- Finally, the collision involved the weakest pier in the structure.

Fig. 3. Views of Damage at Webber Falls (Courtesy of Zolan Prucz)

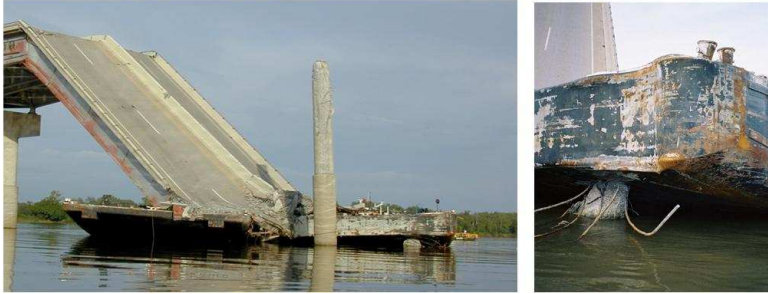
Fig. 4. Views of Damage at Webber Falls (Courtesy of Zolan Prucz)

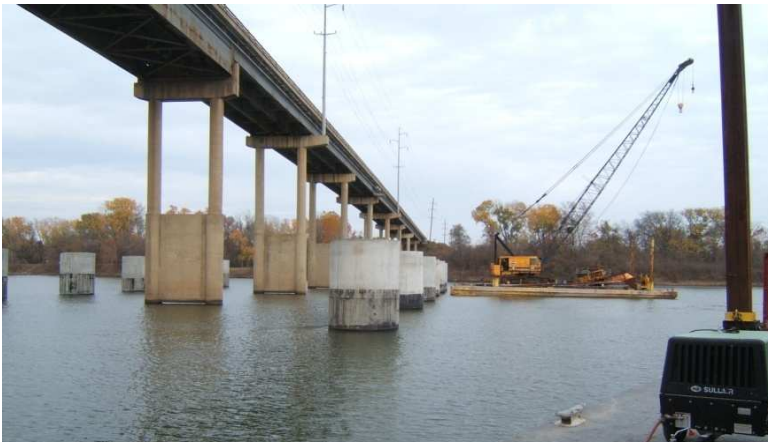
Fig. 5. Vessel Collision Retrofit (Courtesy of Jensen Construction Company)

In this case, the reaction to this event involved operational and policy recommendations for alarms on the controls of tugs to sense whether the controls had not been activated for a particular period of time which might indicate a medical incident involving the pilot. Additionally, dolphins comprised of large diameter, highly reinforced drill shafts were added to protect a number of piers of this and other bridges. Some of these dolphins are shown in Fig. 5.

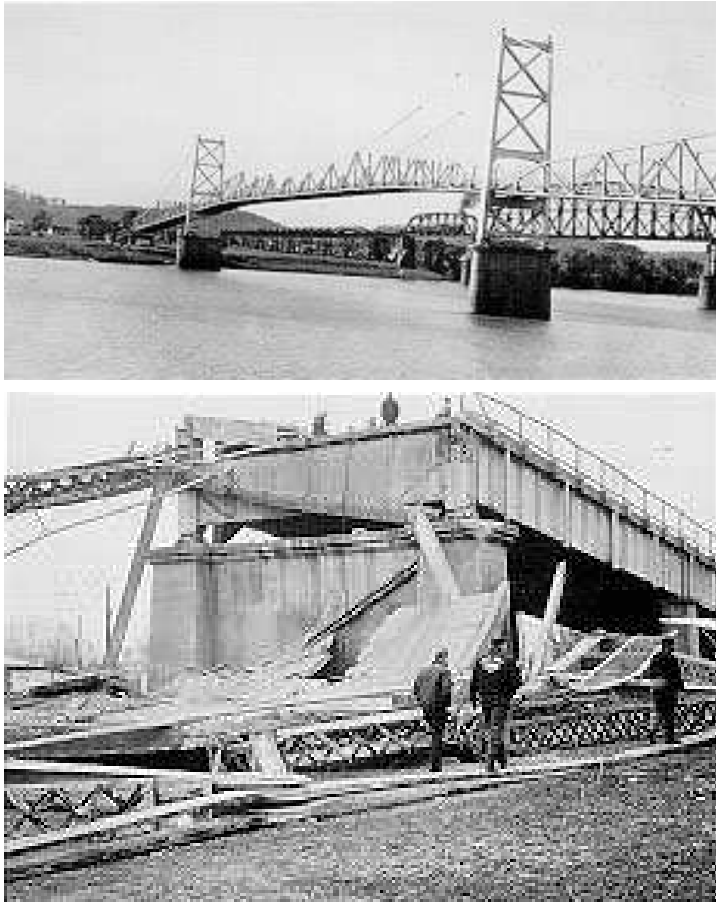
The Silver Bridge across the Ohio River collapsed in December of 1968 [6]. This collapse resulted from the fracture of an eyebar in an eyebar chain suspension bridge shown in Fig. 6. This was a seminal event in United States bridge engineering resulting in several different responses. A fracture control plan was implemented for fracture-critical members which related to the materials and the fracture toughness, the fabrication and welder qualifications and testing procedures, thorough documentation throughout the fabrication process, and careful documentation for weld repairs. The design specifications were altered to require the identification of fracture-critical members, i.e. components whose failure could be expected to result in partial or total collapse of the bridge, in the plan set. In some cases even tension components and structures which are not designated as fracture-critical must now be designated on the plans. Fracture toughness requirements were identified as a material requirement, but were not specifically integrated into the design specifications. From a policy point of view, this collapse resulted in the National Bridge Inspection Standards in

Fig. 6. Views of Silver Bridge Before and After Collapse (Courtesy of FHWA)

the United States as outlined in Title 23 of the Code of Federal Regulations, Part (650 cc). This requires inspection of every bridge at intervals not greater than two years, and further special requirements for the inspection of components regarded as fracture-critical. Redundancy of structures was stressed in the design process and numerical, i.e. computer simulation, demonstrations of redundancy were permitted. In terms of retrofits of existing structures, a virtually identical eyebar suspension bridge was demolished and replaced. Other structures had redundancy added through the addition of auxiliary components.

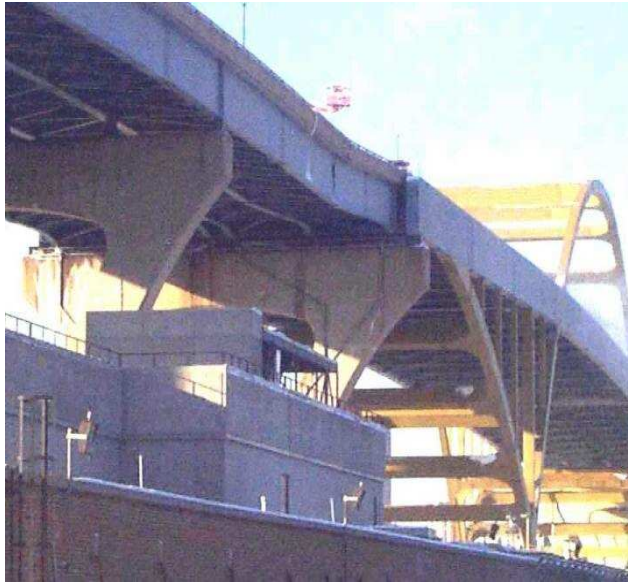
In December of 2000, several cracks were found in the girders of the Hoan Bridge in Milwaukee, Wisconsin, shown in Figs. 7 and 8. As can be seen in Fig. 8, several girders in the same span cracked virtually full-depth. All the fractures were brittle fractures initiating at intersecting welds. The problematic detail causing these fractures is shown in Fig. 9. It involved a series of intersecting welds which resulted in a triaxial stress state. No fatigue cracks were found associated with these problematic details. However, the shelf plate and the lack of a direct connection of the transverse stiffener created a large crack-like detail, which combined with the near inability of the steel to yield because of the intersecting welds, resulted in a scenario for brittle failure.

Fig. 7. General View of Hoan Bridge (Courtesy of FHWA)

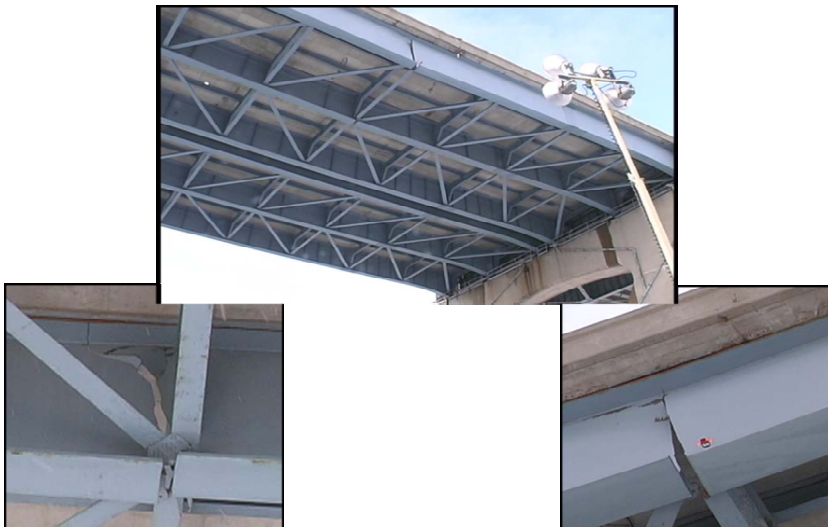
Fig. 8. Close-up of Cracked Area (Courtesy of FHWA)

The body of knowledge was expanded through detailing guidance which involved elimination of the intersecting welds, usually by providing at least a 1/4” space between the welds, to allow for relief of constraint.

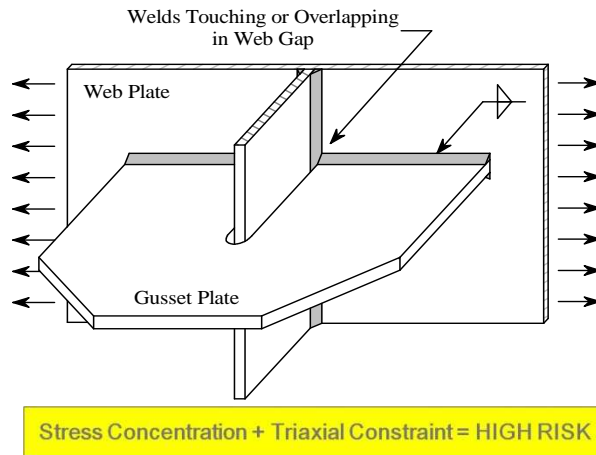
Fig. 9. Problematic Detail (Courtesy of FHWA)

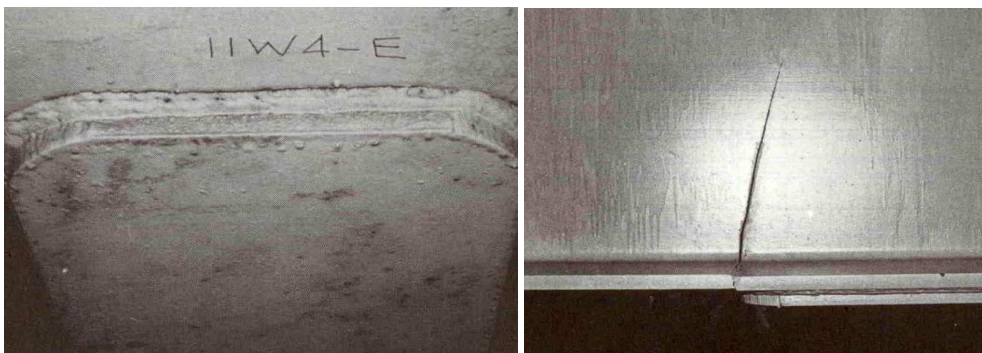
Fig. 10 shows one of the early in-service fatigue failures in the United States at the Yellow Millpond Bridge. As a result of this and other instances of fatigue cracking, significant research projects were undertaken to characterize the response of various types of welded details. The result was an addition to design specifications requiring design on a stress range basis using SN curves for common welded details as shown in Fig. 11. Of course this deals only with the resistance side of the design equation, and studies were also undertaken to quantify the traffic side as well. These are commonly referred to as loadometer studies, and in more recent years weigh and motion studies (WIM). By in large, in United States practice, a relatively successful design specification has evolved for the treating of what is termed „load-induced fatigue”.

Fig. 10. Early Fatigue Crack on Yellow Millpond Bridge (Courtesy of John F. Fisher)

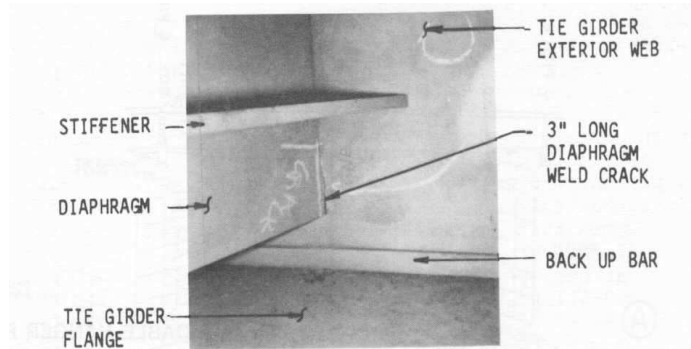
As a practical matter, much of the fatigue damage actually observed in the structures in the United States is related more to what is referred to as distortion-induced fatigue. A typical situation involving that type of response is shown in Fig. 12. This type of damage typically results from a small gap between structural components which is subject to a relatively small movement through the disconnected gap. In this scenario a relatively small displacement can result in a very large stress range. The response to this type of fatigue

Fig. 12. Distortion-induced Fatigue Crack (Courtesy of John M. Kulicki)

damage involved research to attempt to identify the important parameters and the development of a body of knowledge resulting from case studies subject to the research [7]. The specification changes have been limited to the identification of certain types of details which are no longer allowed in design of new structures in the United States. To-date there has been no robust quantification of this type of fatigue in the Design Specifications. Bridge inspectors are routinely trained to be aware of these types of cracks and how to identify suspect details.

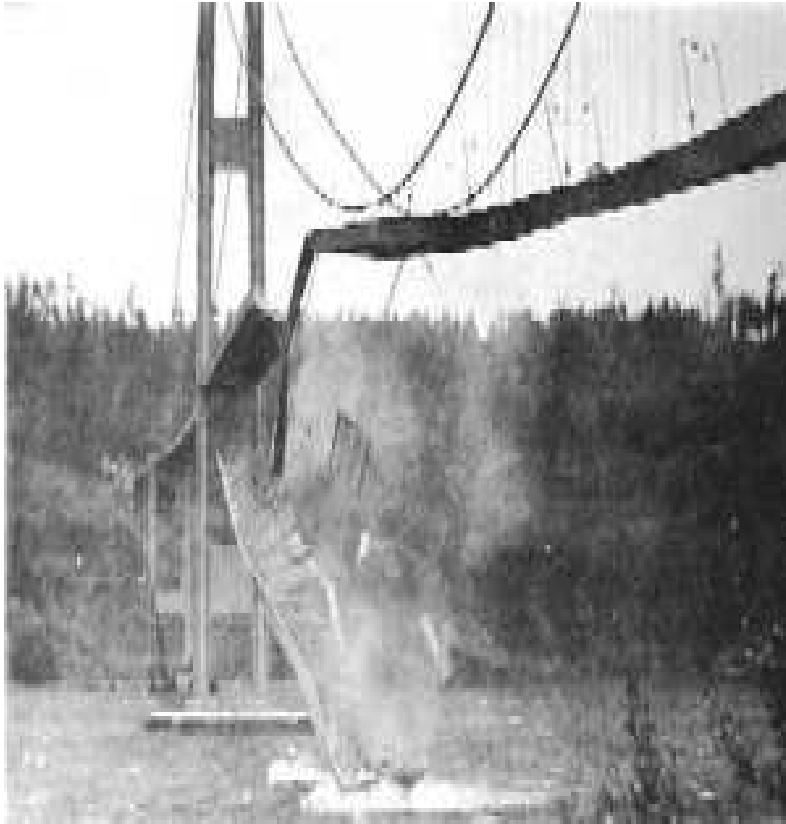
Fig. 13 shows one of the last stages in the collapse of the First Tacoma Narrows Bridge, a failure related to dynamic wind events. As a result of these types of failures, research proceeded to increase the understanding the dynamic response of more flexible structures. Design Specifications were modified to require static design pressures, and in the case of the United States specifications, an overturning line load applied to deck structures. The body of knowledge was expanded on several fronts including the identification of the basic factors involved in aerodynamic stability of structures and testing protocols involving section models, aeroelastic models, terrain models and now computational fluid mechanics-based methods. Fig. 14 shows the aeroelastic model of the Akashi-Kaikyo Bridge in a large wind tunnel in Japan. A variety of structural and dynamic retrofits have been instituted at various structures to either increase the stiffness, add damping or change the aerodynamic characteristics of the cross-section.

Fig. 13. Collapse of First Tacoma Narrows Bridge (Source: Britannica.com)

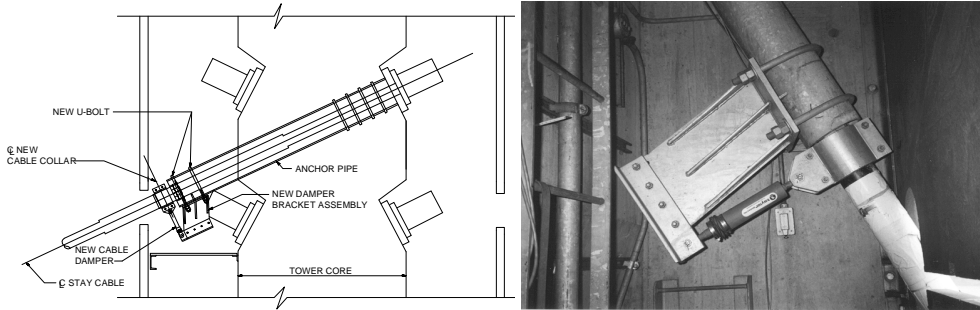
Fig. 15. Damper added to Eliminate Wind-Rain Vibrations (Courtesy of Modjeski and Masters)

cross-section to create large vibrations. There have been some instances where these vibrations have occurred in the absence of the rain further exasperating the search for solutions. Various methods have been used to control these motions, including energy absorbing pads between the cable ends and anchor pipes, cross-tying cables together, counter stays to connect upper reaches of cables to the deck modifying the cable shape to change the aerodynamic characteristics and the installation of energy absorbers or dampers on the cables. One use of cable dampers in a retrofit scenario is shown in Fig. 15.

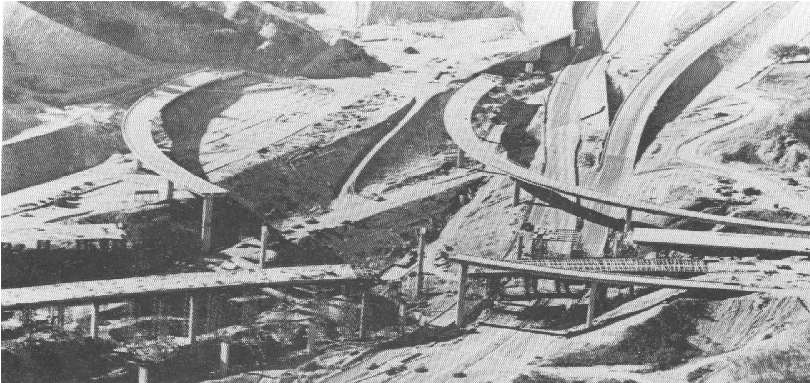
While earthquakes have been part of the natural environment in many parts of the world before the dawn of recorded history, in the United States the earthquake in San Fernando, California, in 1971 was a wake-up call to the design profession. Damage from that earthquake is shown in Figs. 16 and 17.

Fig. 16. Damage to Interchange from 1971 San Fernando Earthquake (Source: California DOT Photo Archives)

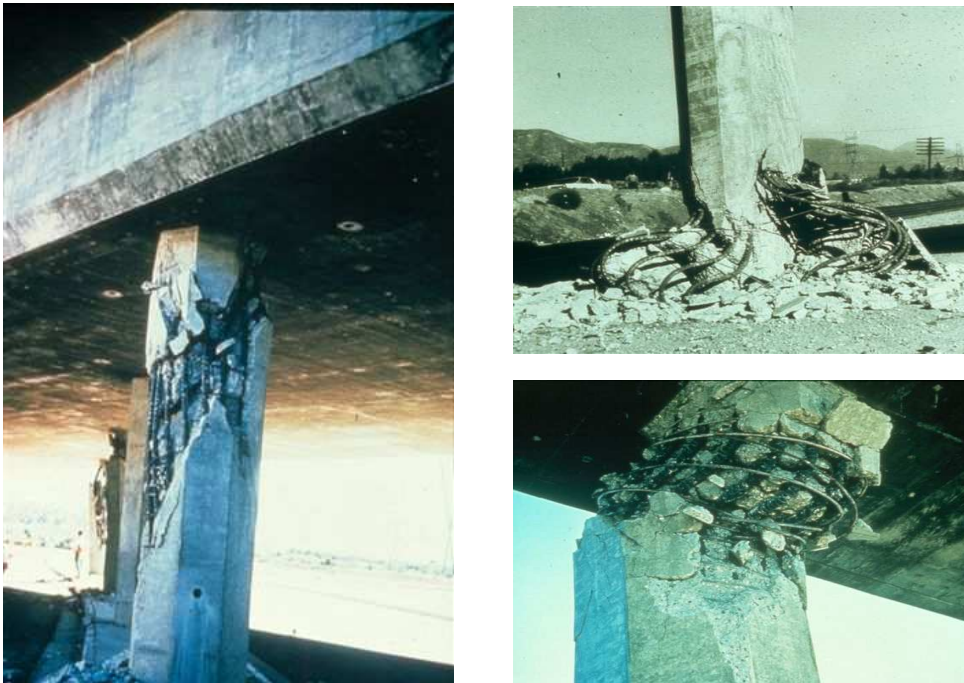
Fig. 17. Typical Column Damage from 1971 San Fernando Earthquake (Source: California DOT Photo Archives)

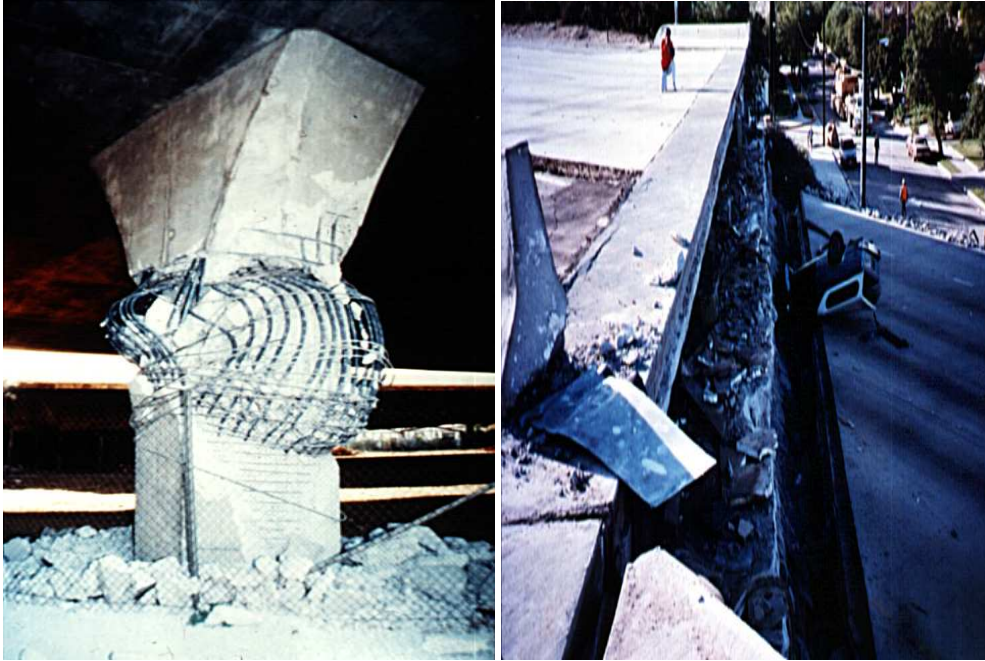
Earthquakes continued to occur and additional lessons were learned. Significant damage was done to structures in the Northridge area by an earthquake which occurred in 1994. Some of the damage inflicted by that earthquake is shown in Figs. 18 and 19. On the positive side, the apparent good behavior of some of the retrofits to structures in California as a result of the earlier earthquakes, including column wrapping, longitudinal restrainers and base isolation, was noted.

Fig. 18. Damage from 1994 Northridge Earthquake (Source: University of Buffalo/MCEER Photo Archives)

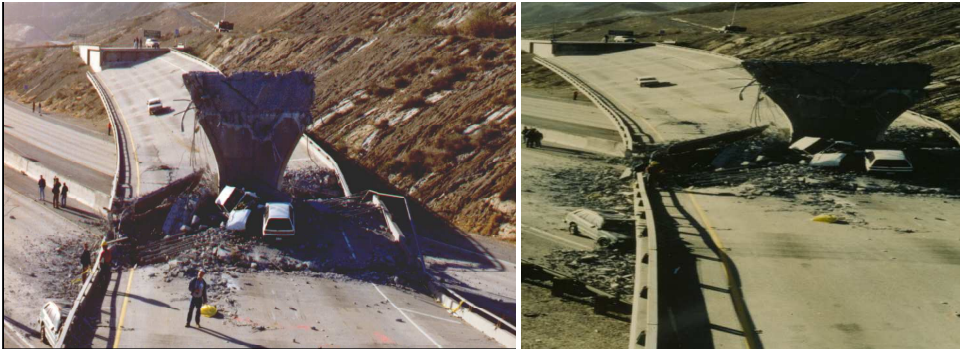
Fig. 19. Damage from 1994 Northridge Earthquake (Source: University of Buffalo/MCEER Photo Archives)

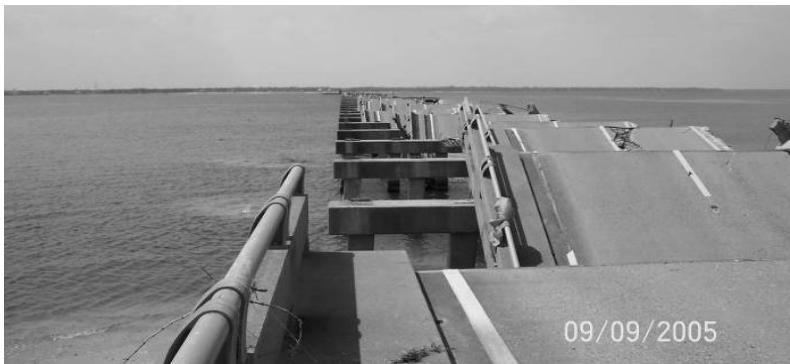
In 2004 and 2005, three hurricanes ravaged the Gulf Coast area of the United States. Several relatively long bridges crossing bays in the coastal areas were destroyed resulting in a replacement cost of over a billion dollars. Typical damage is shown in Fig. 20. In response to this, the Federal Highway Administration initiated a research project to develop a

specification to provide design guidance for the forces encountered in these events [11, 12]. It was believed that the destruction of many spans of prestressed concrete beam bridges resulted from a combination of buoyancy and wave-induced forces. Interestingly, similar phenomena and bridge damage were discussed almost 25 years earlier [13]. A research team consisting of structural engineers and ocean engineers developed a process for calculating the wave forces using relevant meteorological and oceanographic data pertaining to an individual site, based on numerical simulations supported by wave tank studies. A typical experimental response is shown in Fig. 21. This work led to the adoption by AASHTO of a document entitled „Guide Specifications for Bridges Vulnerable to Coastal Storms” [14]. A parallel document on retrofit of existing bridges was also developed, but the magnitude of forces developed in coastal storms make retrofits very difficult and often impractical. Research into wave forces continues and further evolution of these specifications is expected. However, the relatively few instances since 2005 where significant storms have made landfall on the coastal United States has resulted in very little damage since these guide specifications were developed.

Fig. 20. Dislodge Spans of US 90 Bridge over Bay St. Louis, Mississippi, Resulting from Hurricane Katrina 2005 (Courtesy of Mississippi DOT)

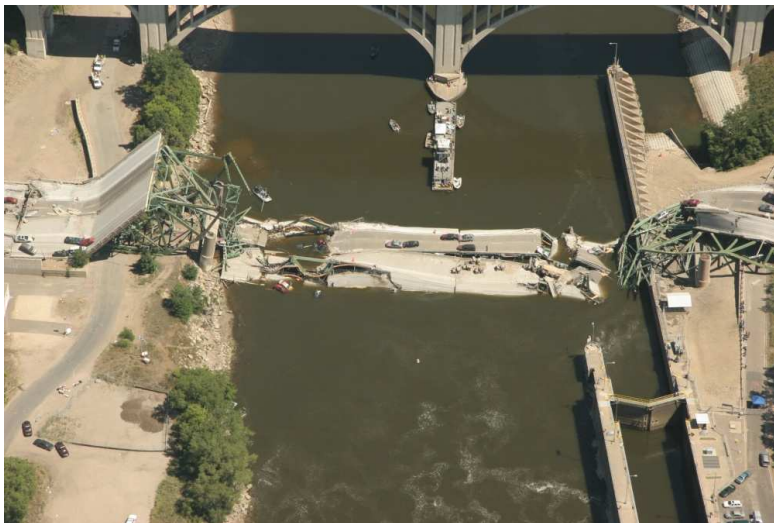
On August 1, 2007, the I-35 structure, which consisted primarily of a multi-span deck truss, collapsed into the Mississippi with a resulting loss of life. An aerial view is shown in Fig. 22. The response to this incident involved extensive investigations into the probable cause [15]. All deck trusses on major roads throughout the United States were reinspected. Particular emphasis was placed on gusset plates as it was quickly realized that the most probable culprit in this event involved a gusset plate which was found to be undersize, combined with certain events of the life of the bridge which increased the loads on the structure and an ongoing redecking operation which may have added additional temporary loads. Initial guidance on the analysis of gusset plates was produced by the FHWA [16] and many states have evaluated existing truss gusset plates using this process. Gusset plates have been strengthened and in some cases rivets have been replaced with high strength bolts to increase shear capacity. Simultaneously, a research project was initiated to characterize the behavior of gusset plates through a combination of sophisticated non-linear finite element analysis and testing of relatively large scale gusset plates. The considerably approximate nature of typical design procedures for gusset plates have been known for decades [17] and the current research program is further quantifying this difference between assumed and actual behavior and is expected to yield revised design specifications based on a much improved understanding of the distribution of stresses in these critical components, improved design methods, and resistance models. As of this writing, the work is still in progress and no codification of results have yet been achieved.

Fig. 22. Aerial View of Collapsed I-35 W Bridge, Minneapolis, Minnesota (Courtesy of FHWA)
