Exponent, Inc., 149 Commonwealth Drive, Menlo Park, CA 94025, USA

## CONCRETE SPALLING IN A SLIP-FORM CONSTRUCTED INDUSTRIAL CHIMNEY

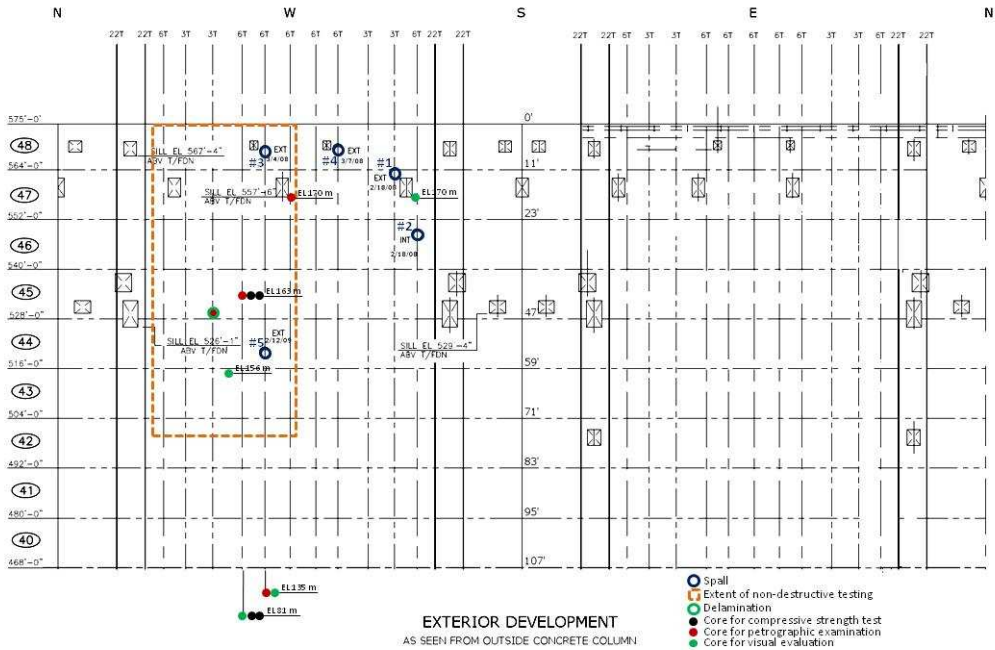
Four concrete spalls were discovered during the first winter after construction and an additional spall occurred during the following winter. All spalls occurred in the top 18 m of the chimney and were clustered within a 60-degree quadrangle of the circumference facing south-west (Fig. 1). The spalls reportedly occurred directly over jacking rods, as

Fig. 1. Locations of spalling (#1 - #5), delamination, non-destructive testing and coring (Note: only top 143 m shown for clarity).

The depth of the detected delamination was approximately 90 mm which corresponds to the location of the external reinforcing mat representing a weak plane. Preferential development of such a weak plane would be expected in areas of reinforcement congestion, which explains occurrence of three spalls at the louvered opening corners (Fig. 1).

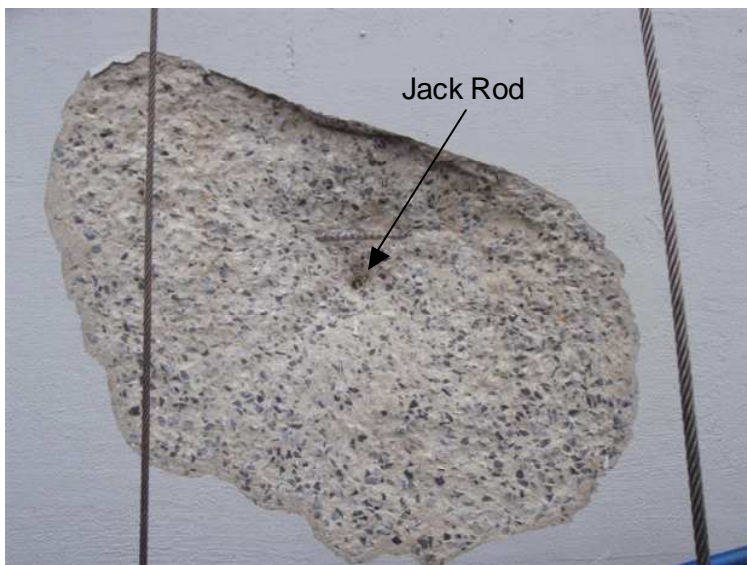
illustrated in Fig. 2. Of the four external spalls, three were near louvered opening corners. The spall characteristics are summarized in Table 1. Although spalling took place before the chimney operation began, relatively large spall size raised a question of hazard for the power plant personnel.

Fig. 2. Spall number 5 (approximate spall size is 1.2×0.6 m).

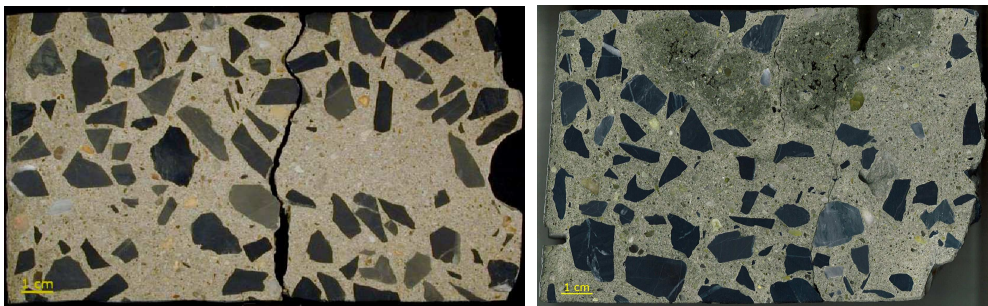
Fig. 3 (left) shows a section of the core obtained at the delamination detected using NDT techniques. The delamination (visible as crack) extends through cement paste (rather than aggregate particles) which indicates fracture development at an early age of concrete.

In addition to non-uniform aggregate distribution, one of the cores contained two dark brown-gray areas at approximately 25 mm and 70 mm from the exterior surface, as shown in Fig. 3 (right). These areas were very hard and contained high content of entrapped air and of lumps of unhydrated portland cement. These cement lumps as well as non-uniform aggregate distribution were likely the result of improper batching sequence of concrete ingredients while using hot water in the concrete mix [2].

Fig. 3. Core sample cross-sections (left side of core sections indicates chimney shell exterior).

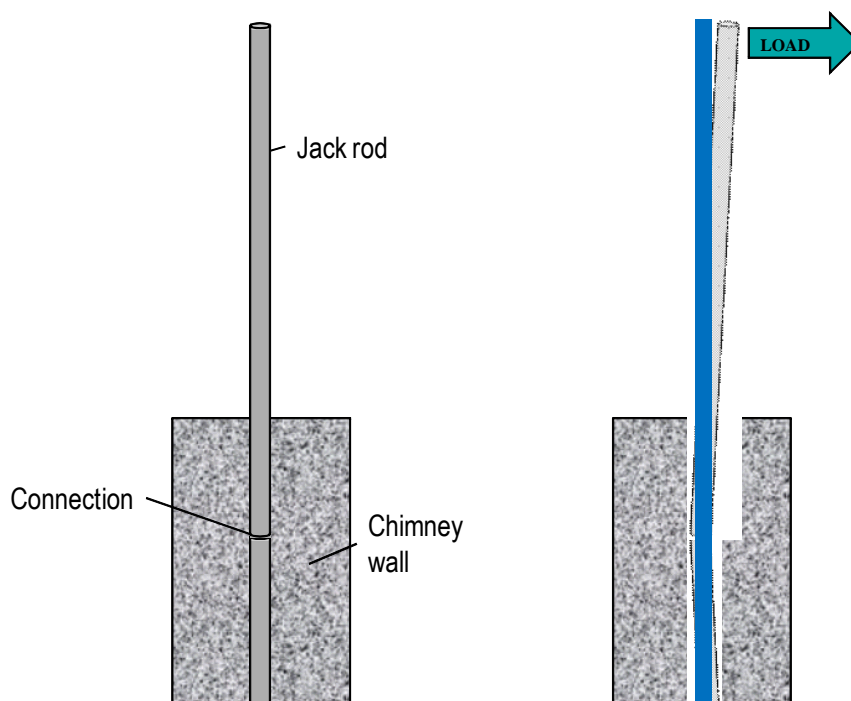
jack rods in delamination formation is evident from the fact that the majority (if not all) of the spalls as well as the detected delamination were directly centered over jack rods. Because the jack rods protruded from the concrete and were directly connected to the formwork and associated platforms during construction, they were subjected to substantial wind loads. Jack rod movement due to high winds during construction exerted tensile stresses that exceeded the relatively low early-age tensile strength of concrete, thus leading to fracture development. A schematic illustration of wind-induced jack rod movement is shown in Fig. 4.

Fig. 4. Conceptual illustration of wind-induced concrete damage during construction.
