Kansai University, Osaka, Japan

Kinki Regional Development Bureau, Ministry of Land, Infrastructure and Transport, Osaka, Japan

EFFECT OF REINFORCING METHOD AGAINST FATIGUE CRACKING OF ORTHOTROPIC STEEL DECK WITH BULB RIBS

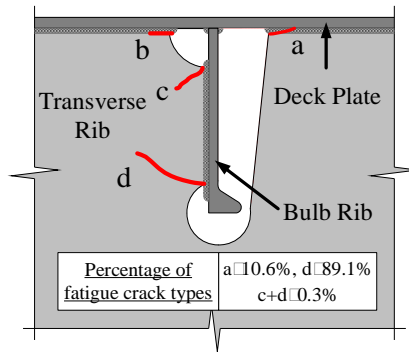
Recently, thousands of fatigue cracks have been detected in orthotropic steel decks in Japan. Of these, fatigue cracking in welded joints between bulb ribs and transverse ribs is the most frequent type found in the Kansai area (Committee of JSCE on steel structures 2007). Fatigue cracks are classified into 4 types, as shown in Figure 1 (Tabata et al. 2007). At the intersection of the bulb rib and the transverse rib, the crack that propagates from the weldment of the lower part of the slit into the transverse rib web is d-type, and the other

that propagates from the weldment of the upper part of slit into the deck plate is a-type. These cracks may propagate into the deck plate and have a bad influence on traffic.

Figure 1. Fatigue cracks in welded joint between bulb rib and transverse rib in the Hanshin Expressway

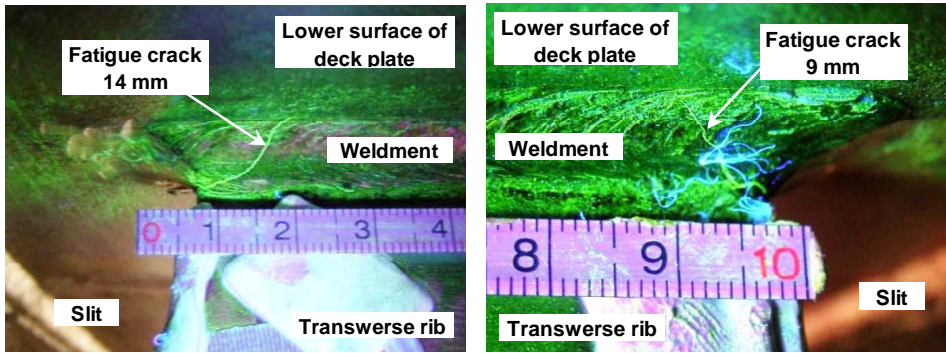
A fatigue crack of 14 mm length was detected on the weldment of the upper part of the Rib 1 slit after 0.7 Mcycles loading. Photo 2 shows the fatigue crack at this upper part of the Rib 1 slit after 0.7 Mcycles loading. It was initiated at the weld toe of the upper part of the Rib 1 slit, and propagated from the weldment into the deck plate. After 5.4 Mcycles loading, it propagated to about 30 mm length, as shown in Photo 3.

(a) South side (b) North side
Photo 2. Fatigue crack at upper part of Rib 1 slit after 0.7 Mcycles loading

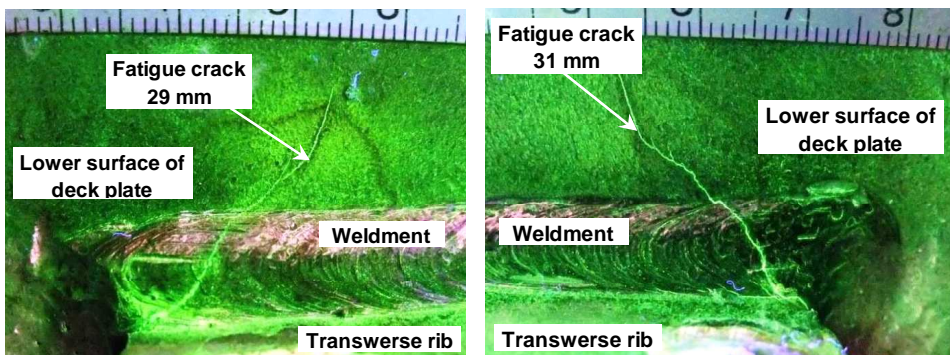
(a) South side (b) North side
Photo 3. Fatigue crack at upper part of Rib 1 slit after 5.4 Mcycles loading

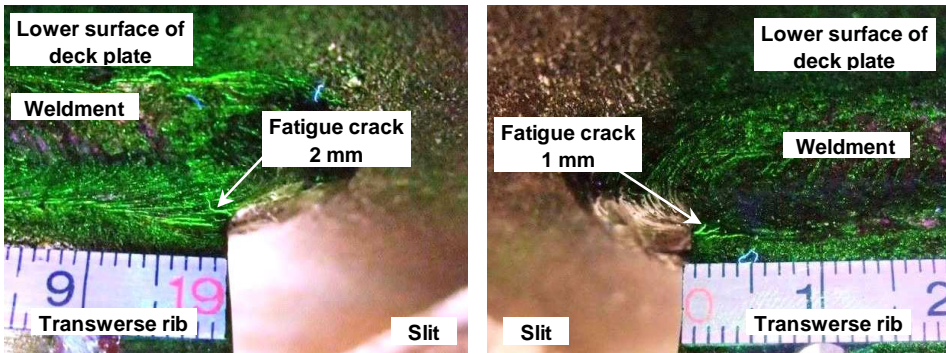
No fatigue cracking was observed at the intersection of Rib 8 and the transverse rib, which had applied angle steel reinforcement, after 5.4 Mcycles loading. Therefore, it was confirmed that the fatigue crack detection life of the welded joint between the bulb rib and the transverse rib had been improved more than eight times by applying angle steel reinforcement. We then removed the angle steels applied to the intersection of Rib 8 and the transverse rib. Without the angle steels, a fatigue crack of 2 mm length was observed on the weldment of the upper part of the Rib 8 slit after 0.1 Mcycles loading. Photo 4 shows the fatigue crack at the upper part of the Rib 8 slit after 0.1 Mcycles loading without angle steels.

(a) South side (b) North side
Photo 4. Fatigue crack at upper part of Rib 8 slit after 0.1 Mcycles loading without angle steels

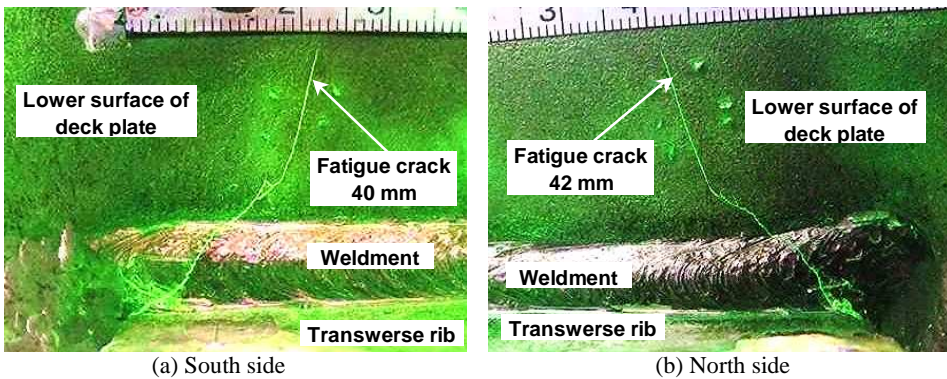
Figure 7 shows the relationship between the fatigue crack length and the number of loading cycles. The vertical axis represents the fatigue crack length, while the horizontal axis represents the number of loading cycles. Fatigue cracks of Rib 1 and Rib 8 continued to propagate slowly after propagating into the deck plate. After 11.1 Mcycles loading, the fatigue cracks of Rib 1 and Rib 8 propagated to about 40 mm and 25 mm length, respectively, but they did not propagate to the upper surface of the deck plate. Photo 5 and 6 show the fatigue cracks

at the upper part of the slit after 11.1 Mcycles loading. Fatigue cracks were not observed in other welded joints between the bulb ribs and the transverse rib.

Photo 5. Fatigue Cracks at Upper Part of Rib 1 Slit after 11.1 Mcycles loading

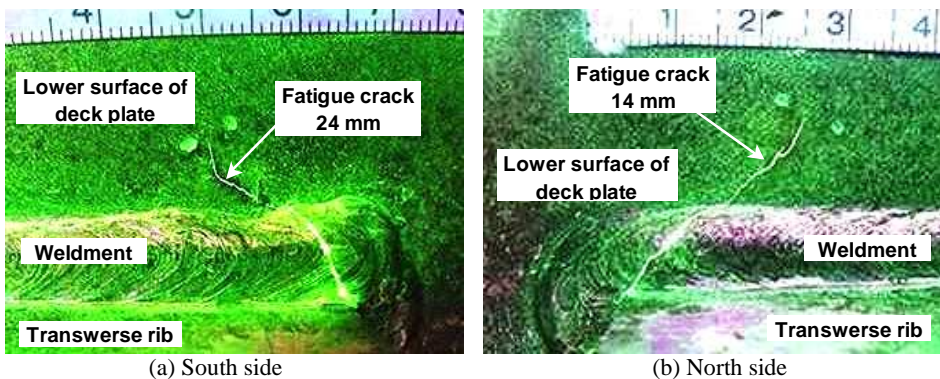
Photo 6. Fatigue Cracks at Upper Part of Rib 8 Slit after 11.1 Mcycles loading
