MASAHIRO SAKANO, *peg03032@kasai-u.ac.jp*  
DAISUKE YAMAOKA, *yamaoka\_dai\_ssd@yahoo.co.jp*  
TETSUYA MIZUNO, *mizuno\_ssd@yahoo.co.jp*  
Kansai university, Osaka, Japan

## FATIGUE BEHAVIOUR OF MISALIGNED BUTT WELDED JOINTS IN THE BOTTOM FLANGE

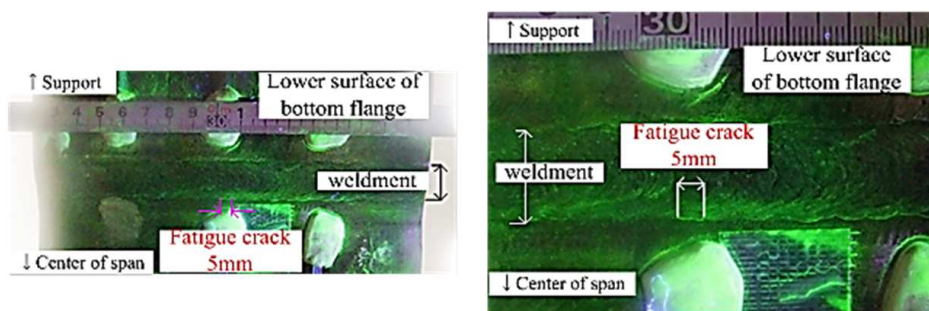
In the G2 specimen, fatigue cracks were detected at the M4 and M4T joints after 1.8 Mcycles loading under  $\Delta P = 130\text{ kN}$  (Photo 4, 5). Also, three fatigue cracks were detected at the longitudinal welded joint between the web and the bottom flange near the M4T (Photo 5) and M0 joints and in the section of the loading point. After reinforcing at those longitudinal welded joints with fatigue cracks (Photo 6), fatigue tests were continued. The fatigue test was finished the fatigue test when the fatigue crack of the M4 joint was propagated into the web. Photo 7 shows the fatigue cracking in the M4 joint. Photo 8 shows the fracture surface in the M4 joint. The fatigue crack was initiated at the weld toe on the lower surface of the bottom flange just under the web, and propagated to the web and the bottom flange. No fatigue cracks were detected at the M0 and M2 joints.

Photo 4 Fatigue crack at M4 joint in G2 specimen after 1.8 Mcycles loading

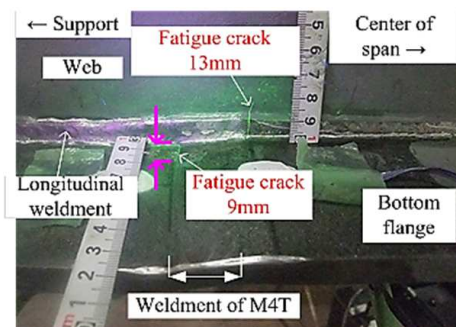
(1) Long shot

Photo 5 Fatigue cracks at M4T joint in G2 specimen after 1.8 Mcycles loading

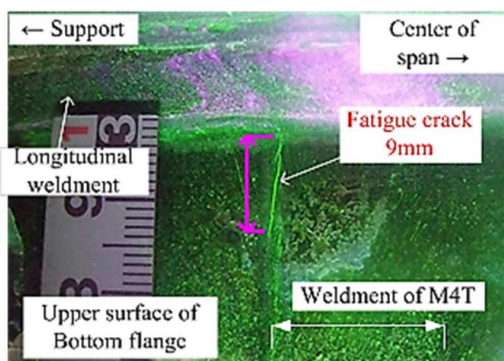
(2) Closeup shot of crack at weld toe of M4T

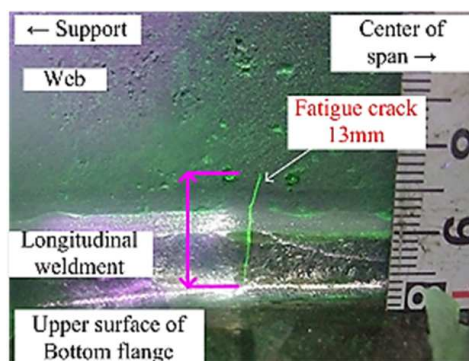
(3) Closeup shot of crack at longitudinal weldment

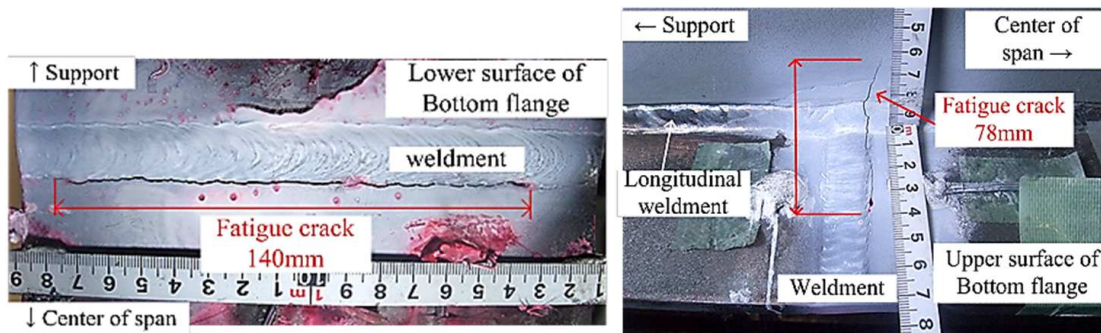
Photo 7 Fatigue crack at M4 joint in G2 specimen after 4.1 Mcycles loading

Because no fatigue cracking was detected at the M0 and M2 joint of 3 specimens, the fatigue strength of M0 satisfied Class C, and that of M2 satisfied Class D. At M4 joints, no fatigue cracking was detected under  $\Delta\sigma = 66$  MPa, however a fatigue crack occurred and  $N_f$  satisfied Class D under  $\Delta\sigma = 87$  MPa. Therefore, the fatigue strength of M4 was about Class E or D. The results show that the fatigue strength of the 18% misaligned butt welded joint (M2) satisfied Class D, as recommended for a butt welded joint without finishing by JRA. However, the fatigue strength of the butt welded joint may decrease from Class D to Class E with 36% misalignment.

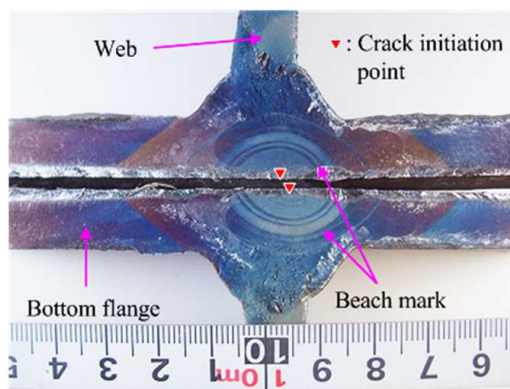
Photo 8 Fracture surface of fatigue crack at M4 joint in G2 specimen
