Piotr D. Moncarz*, moncarz@exponent.com

DELAMINATION IN A PRESTRESSED CONCRETE WALL – A MULTI-BILLION DOLLAR DISTRESS IN A NUCLEAR POWER PLANT

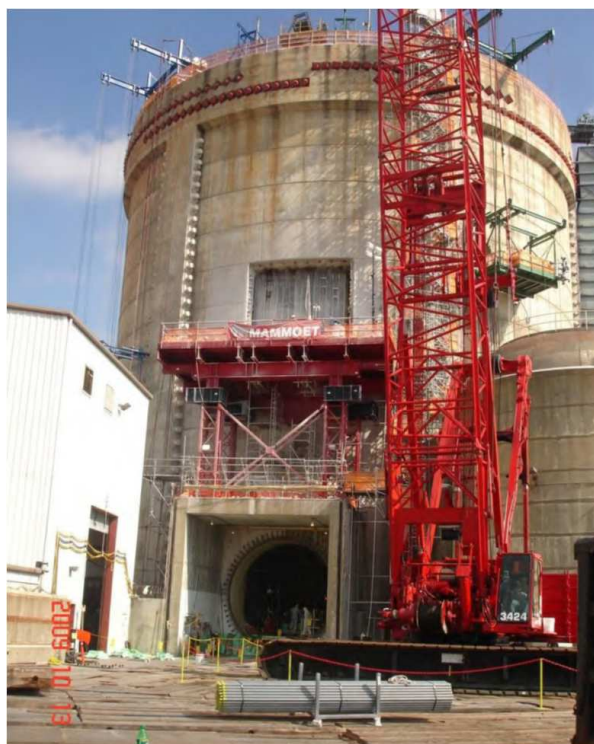
As was typical for the 1970's design, the replacement of the 500-ton steam generator was envisioned at the time of construction of the unit as being done via an access hatch. However, over time it was determined that the congestion of piping and equipment inside the containment structure, and the auxiliary facility density on the outside, would make the transfer of the steam generator very difficult, and a method was developed of cutting a temporary opening in the containment shell at a high elevation above the ground level. The planned opening was 8200×7600 mm (Figure 2). To start the cutting of the opening detensioning of tendons crossing the future opening area was carried out. Two tendons were detensioned using hydraulic ram, 25 tendons were detensioned using flame cutting. The concrete was then removed using hydraulic pressure.

Figure 2. Original access hatch with the temporary Steam Generator Replacement opening

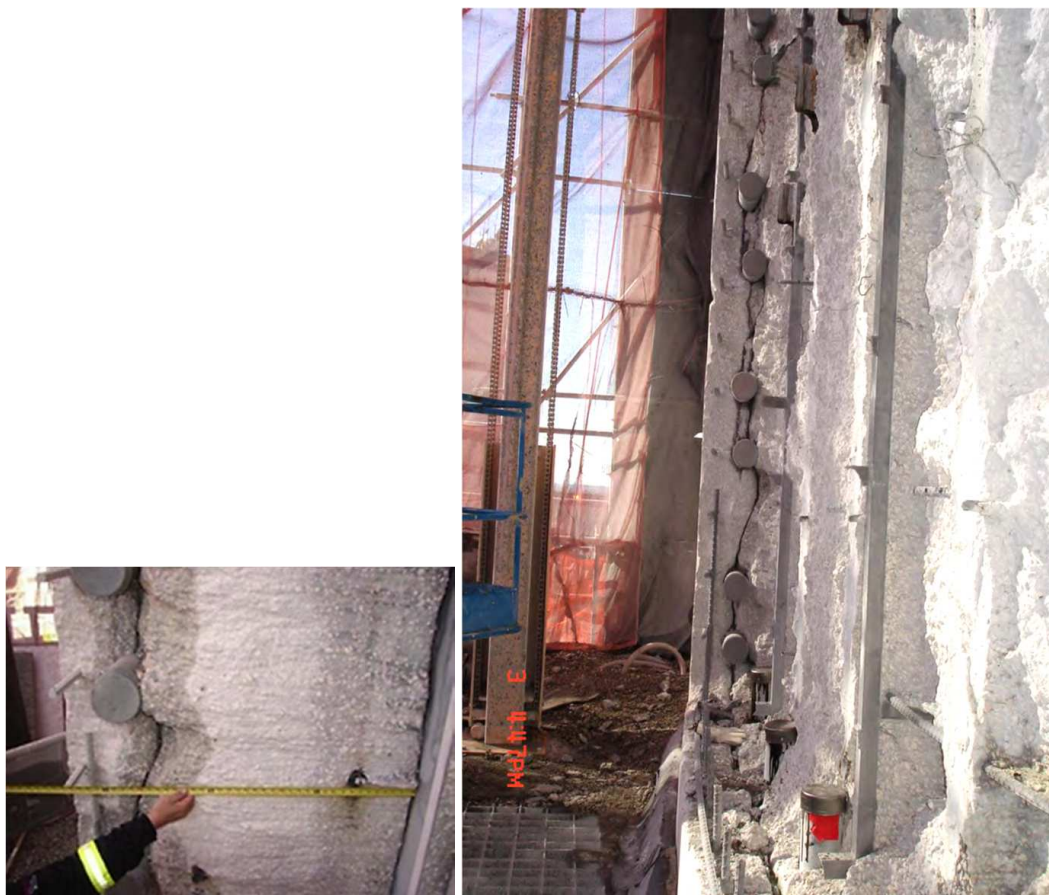
Upon removal of the concrete using hydraulic jet demolition, a delamination running generally along the plane of the tendons was identified (Figure 3). The delamination, while initially thought to be limited to the immediate vicinity of the opening was found to cover

nearly the entire area between the two buttresses between which the opening was cut. Moreover, when detensioning and re-tensioning was carried out in the repair effort, new areas of delamination in other bays were identified through ultrasound testing.

Figure 3. Delamination of concrete along the line of the prestress-tendons.

Deformation survey of the entire area surrounding the temporary opening, and delamination mapping were carried out. Numerical analysis was carried out using non-linear finite element models of the entire structure, detailed model of the temporary hatch area, and micro-level model for the tendon and surrounding concrete. Indeed with accurate input of concrete properties and refined modeling of the conduits it was possible to reproduce delamination of the concrete coincidental with the weekend plane of the tendon location subject to transition from radial compression of the inward located concrete to radial tension of the outward located concrete. The deformation of the structure was beyond its over 30 years of operation and strongly influenced by long-term creep.

Designing of thick-wall reinforced or prestressed concrete containment structures creates opportunities for second order stresses to become a primary cause of distress under ordinary operational conditions. Temperature, shrinkage, and creep are the primary driver of those conditions. However, high gradient stress reversal from compressive to tensile causes conditions which can lead to split cracking and delamination such as observed in the described case. Torturous stress flow path should be avoided in those areas. The large diameter and closely spaced prestress tendon conduits created a plain of such discontinuity where the compressed inner portion of the cylindrical wall was pulling inwards on the external portion of the wall.

The containment repair plans included numerous trials, both experimental carried on the structure and on full scale mock-up wall segments, and analytical consisting of large number of repair scheme and post-tensioning restoration scenarios. In the final conclusion a repair consisting of pin ties installed with epoxy bonding in the radial direction of the wall was considered a reliable and constructible solution. However, large areas of the containment structure external walls were not accessible because of attached buildings. The owner was told that the uncertainty as to how many such ties would have to be installed and how well they might provide constraint to new concrete delaminations upon re-post-tensioning of the structure might have a significant impact on the cost of the repair. Indeed, a probabilistically defined range of \$1,500 mln USD (repair) to \$3,400 mln USD (replacement). As a consequence of those very high numbers and with a large probable spread in the final cost, the owner decided to apply for permission to decommission the unit.
