TECHNICAL CAUSES OF THE COLLAPSE OF DE LA CONCORDE OVERPASS IN LAVAL, CANADA

BENOIT BISSONNETTE, *benoit.bissonnette@gci.ulaval.ca*
Research Center on Concrete Infrastructure (CRIB)
Dept. of Civil Engineering, Laval University, Quebec City (QC), Canada

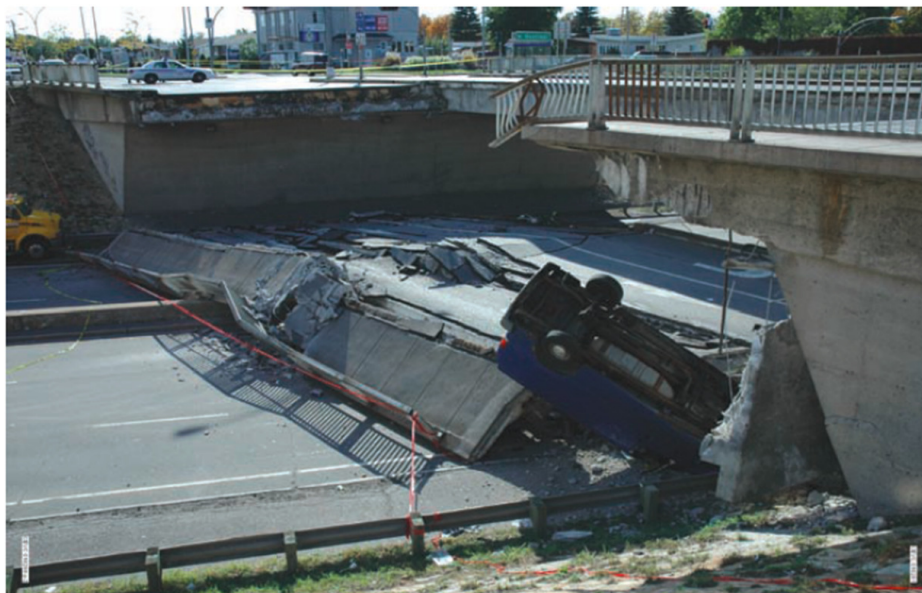
Fig. 1. View looking to the west of the collapsed *de la Concorde* overpass, from the east abutment, on September 30, 2006

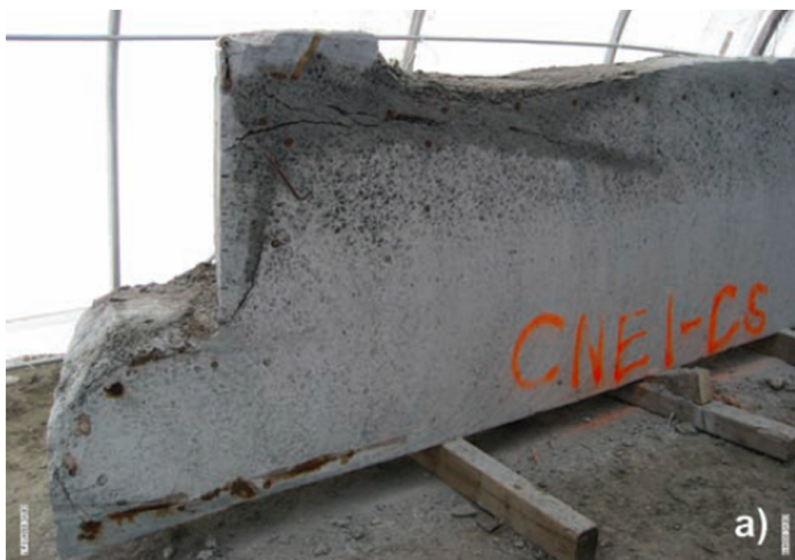
Experts agreed that the overpass collapsed as a result of shear failure of the south-east cantilever. Deterioration of the concrete and not that of the rebar was behind the collapse. The collapse was due to the development and growth of a crack in a zone of weakness located under the upper rebars starting from the beam seat area. Over the years, the freeze-thaw cycles, along with de-icing salts, caused the concrete to deteriorate in this area (see Fig. 3). This deterioration caused a cracking plane to spread inside the thick slab.

Fig. 3. Longitudinal section of the non-collapsed part of the slab showing the presence of highly deteriorated concrete on the surface of the thick slab, behind the shoulder of the joint
