DAMAGE OF CONCRETE STRUCTURES DUE TO AGING

Joost Walraven
Delft University of Technology, The Netherlands

Keywords: aging infrastructure, corrosion of concrete, alkali aggregate reaction, carbonation, chloride penetration, life prediction of structures.

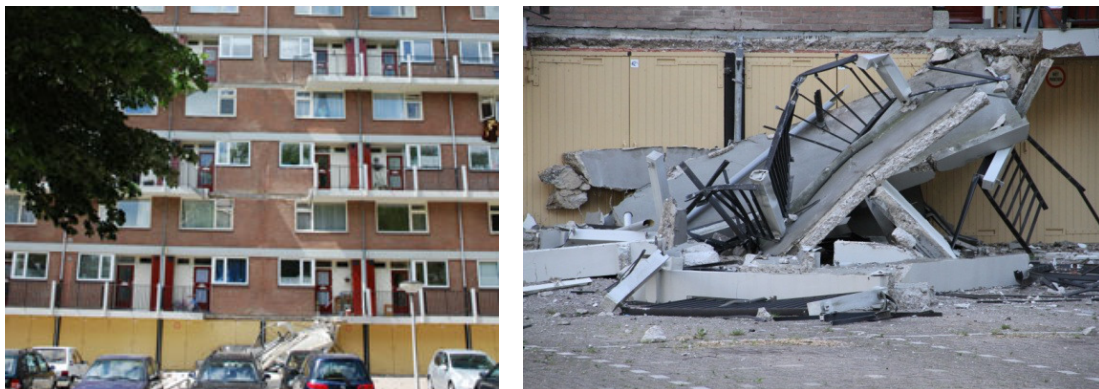
Fig. 1. Unannounced collapse of gallery plates in an apartment building in Leeuwarden, The Netherlands, 2013

The collapse turned out to be caused by corroded reinforcement. A remarkable observation was that the structure fulfilled the code criteria of today. There were no cracks and no signs of upcoming problems due to for instance spalling of the concrete cover. That illustrates that obviously our knowledge about deterioration processes is not yet good enough. In this paper it is argued that we meanwhile know a lot about deterioration, but as well that crucial knowledge is missing.

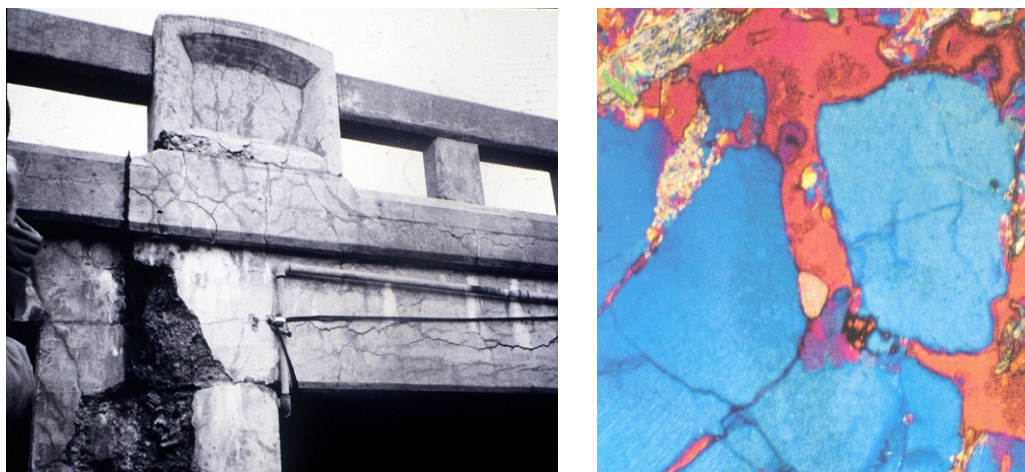
Fig. 2 a. Part of a bridge structure attacked by alkali aggregate reaction, b. Physical reaction leading to expansion of the concrete

An important phenomenon is the effect of restraint of the concrete swelling by reinforcement. Fig. 2a shows that the cracks in the beam tend to develop in the horizontal direction. The reason is that that in the axial direction the longitudinal reinforcement counteracts the swelling and in this way generates a type of prestressing. In the vertical direction often no or limited reinforcement is present, so that the expansion can develop freely, resulting in horizontal crack formation. These cracks may reduce the shear capacity of the bridge [1].

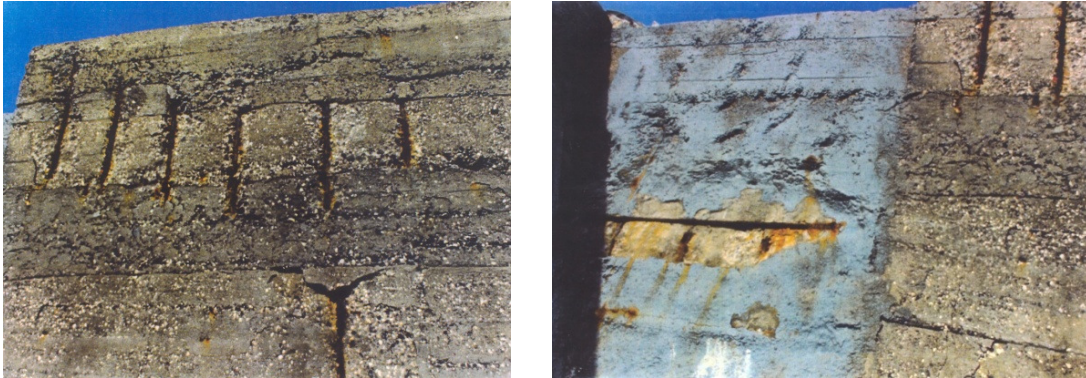
Fig. 4. a) Damage due to chloride induced corrosion in a harbour jetty in Sicily, Italy, b) Unsuitable solution with a coating

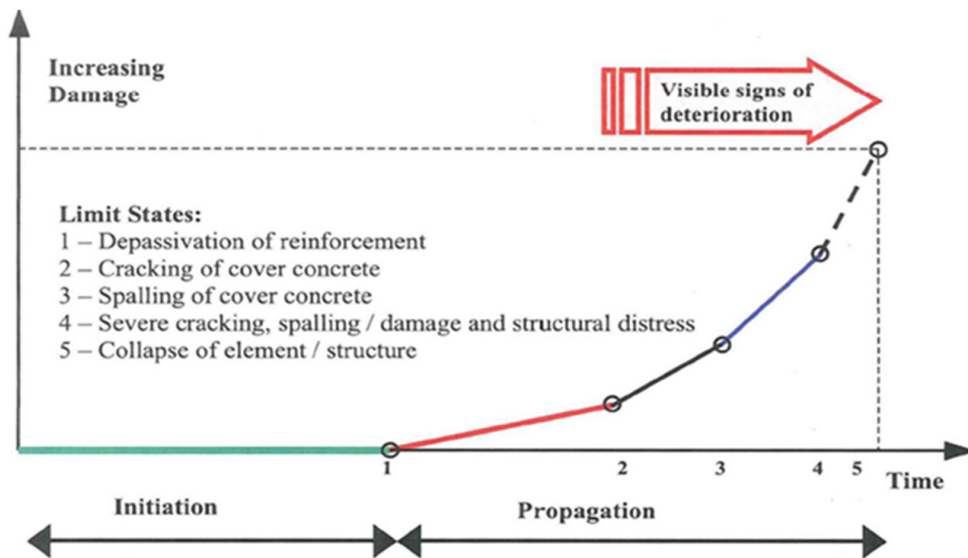
Fig. 5. Deterioration due to chlorides in reinforced concrete

Chloride induced corrosion is by far the most important cause for deterioration and as such reduction of structural safety in time. If the concrete cover is too small and the concrete quality too low, chlorides penetrate until the reinforcement. Corrosion starts as the chloride concentration at the reinforcement has reached a limit value. Fig. 4 shows the result of such a process and a desperate attempt to stop it by applying a coating (Fig. 4 right), which was deemed to fail. A well known representation of the deterioration process as a function of time is shown in Fig. 5. Until the end of the initiation time no damage is assumed to occur, since the corrosion process starts only after the chloride content at the reinforcement has reached a critical value. The events after the start of corrosion (so after reaching point 1 in the diagram in Fig. 5) were considered to be quite uncertain with regard to their timely development.

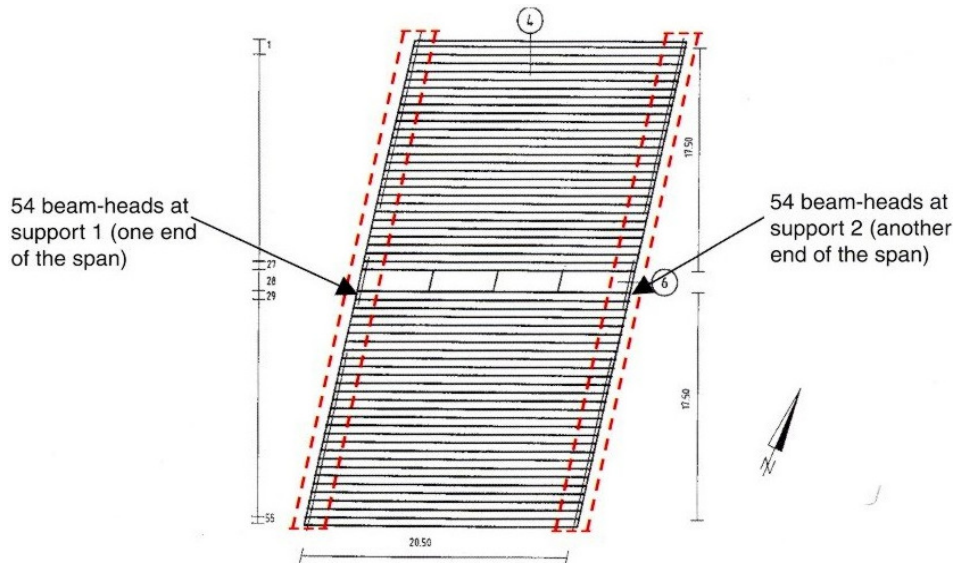
Fig. 6. Top view of bridge Wilpsedijk

A trial calculation of the probabilistic determination of the deterioration of a structure was made based on [2]. The calculation was made for a bridge in the Netherlands, with 54 beams with a length of 20 m. Fig. 6 shows a top view of the bridge.

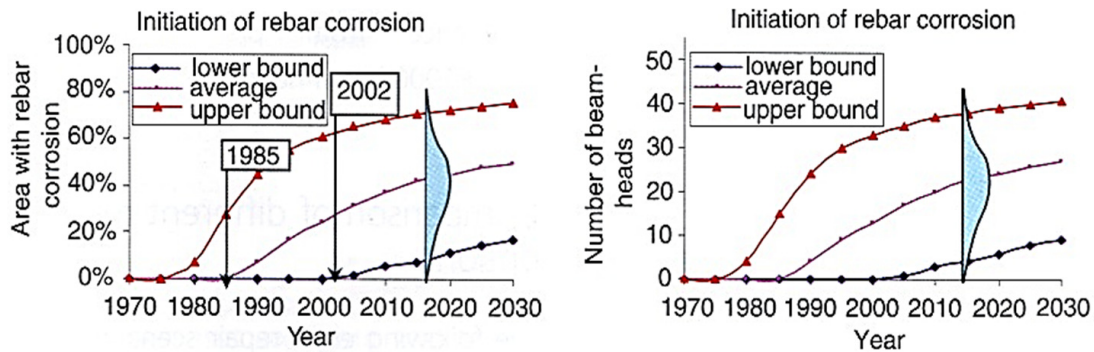
Fig. 7. Prediction of area of rebar corrosion and number of damaged beam heads [2]

Fig. 7. shows the results of the calculation for the deterioration progress. It shows that there is a substantial difference between the lower bound and the upper bound of the prediction, due to the uncertainties involved. The calculation was carried out starting in 1985, the year of construction. The calculation could be calibrated based on the results of an inspection in 2002. This calibration made it possible to determine which curve fits to the bridge considered. On this basis the behaviour of the bridge for the following years could be predicted and decisions could be made with regard to the maintenance strategy.

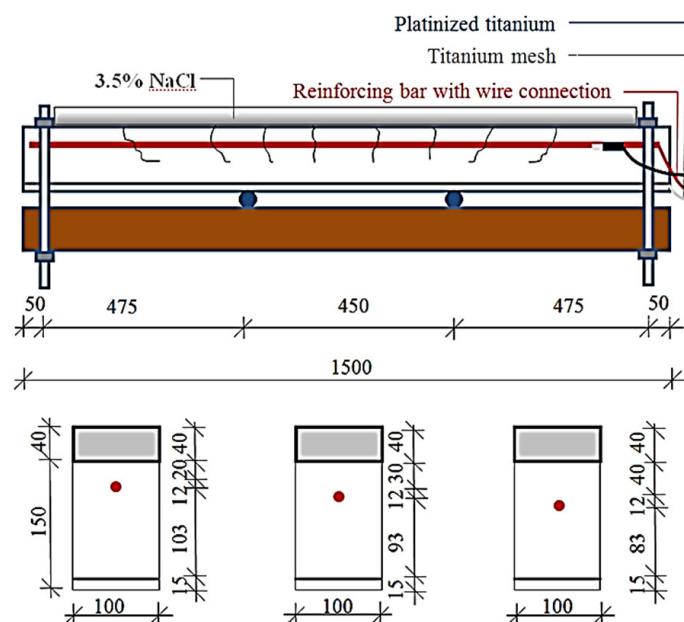
Fig. 8. Test specimens for the determination of the role of crack width on durability carried out at TU Delft

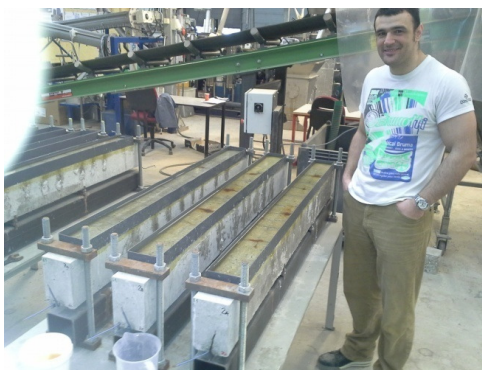
Fig. 9. PhD researcher Andrija Blagojevic in front of some of his 32 beams

In the following some of the results are given. In Table 2 the parameters are given of the beams, the behaviour of which is compared in Fig. 9.

Table 2. Data for beams, the corrosion development of which is compared in Fig. 9

Series	Concrete cover (mm)	Mean crack width (mm)	Number of cracks	Type of loading
14B	40 mm	0.15–0.25	6	Variable
15B	40 mm	0.25	6	Static
16A	40 mm	0.20	6	Static
15A	40 mm	0.15	6	Static

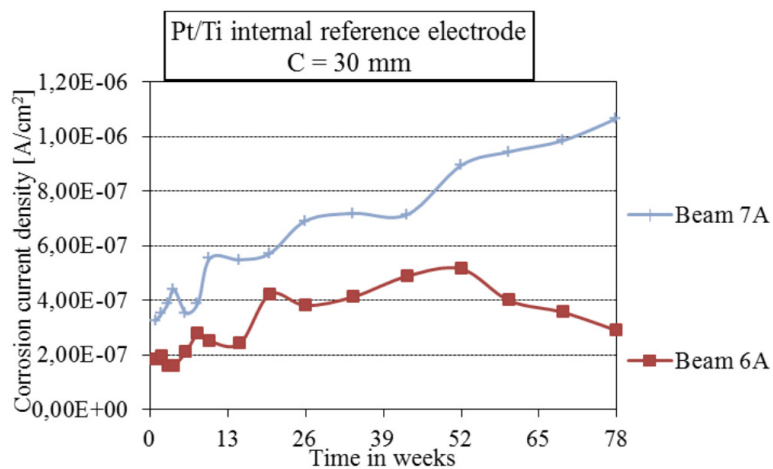
Fig. 11. Corrosion current density as a function of time in weeks for beams with various types of loading

The diagram shows that there is clear tendency of a higher corrosion current density with increasing average crack width. Another interesting observation is made in Fig. 11, where the behaviour of two beams is compared with similar geometry. Beam 6A has a mean crack width of 0.15 mm and is subjected to a static load. Also beam 7A has a mean value of 0.15 mm, but the crack width varies between 0.10 mm and 0.20 mm due to the variable load.

It is seen that the second beam shows a significantly higher corrosion current than the first one. There may be two reasons for this observation. The first is that under the variable load no crack healing can occur. The second is that the maximum crack width is governing for the rate of corrosion, as suggested also by Fig. 10.

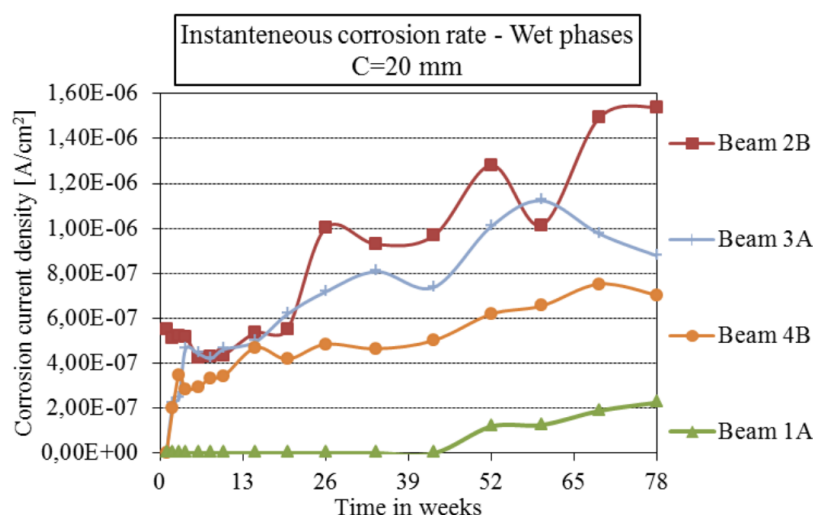
Fig. 12. Corrosion as a function of time for beams with different types and number of cracks.

In Fig. 12 it is seen that beam 2B, with a mean crack width of 0.15 mm, but with an additional longitudinal crack, shows a larger corrosion current density as the similar beam 3A, without a longitudinal crack. The beam 4B, with 6 cracks shows a smaller corrosion current density than the similar beam with 9 cracks (in beam 4B 3 cracks were coated, so corrosion is prevented): this can be explained on the basis of the measuring system, which included the resistance over the full length of the bar, so that 9 cracks offer a larger resistance due to a larger number of corroded bar areas.

Finally, as expected, the beam without cracks shows the lowest corrosion activity. The first signs of corrosion are observed after about 40 weeks.

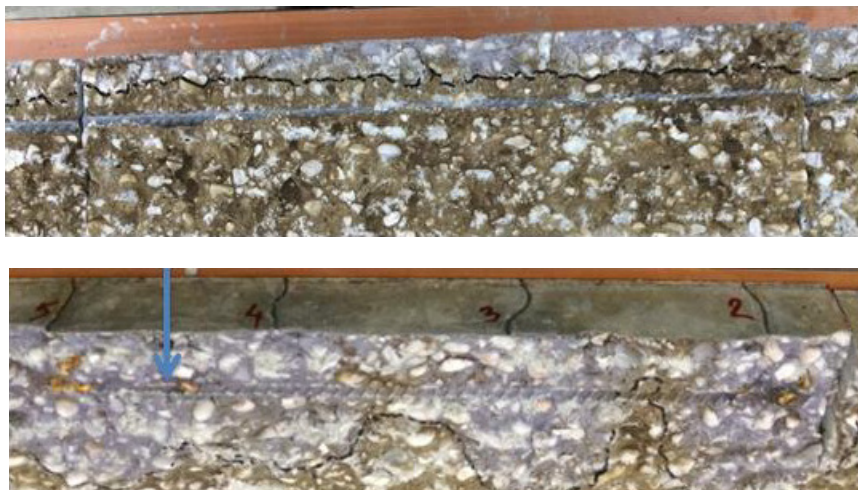
Fig. 13. a) Chloride-intruded area in beam without bending cracks (light area), b) Chloride-intruded area in beam with bending cracks (light area)

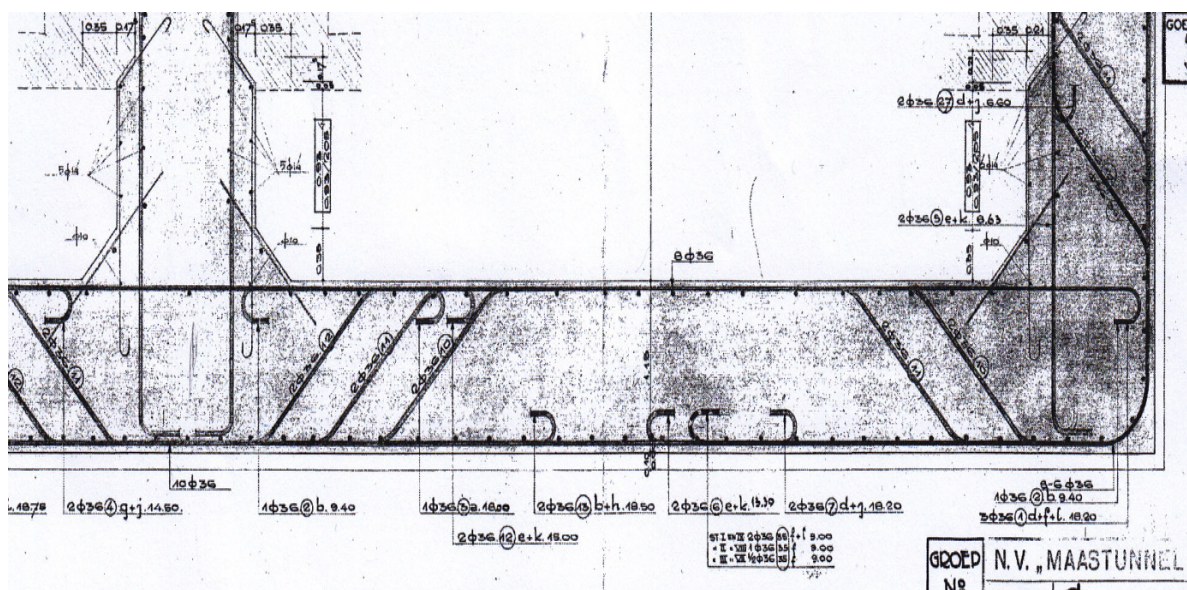
Fig. 13. Original design drawing of bottom slab of Maas Tunnel Rotterdam, 1937

A stunning example of a structure which turned out to be substantially stronger than expected was the Maas Tunnel in Rotterdam, The Netherlands. This tunnel, constructed between 1937 and 1942, is the first immersed tunnel in the world. During visual inspection of the bottom of the tunnel (Fig. 13) it turned out that there was major concrete damage. The concrete cover was loose over an extended area and substantial corrosion of the reinforcement was observed.

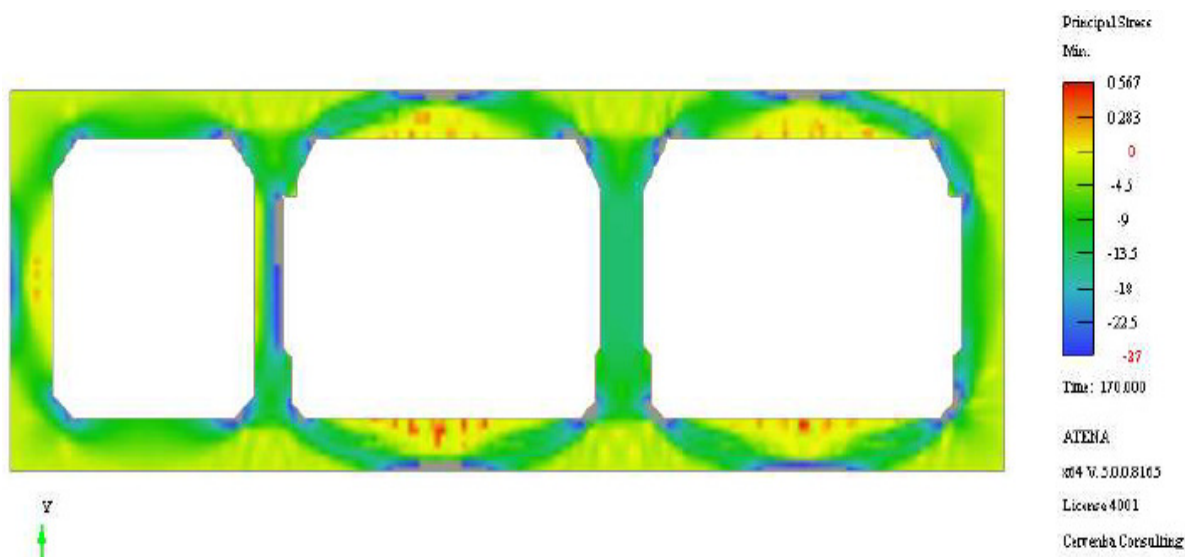
Fig. 14. Analysis of the structural safety of the Maas tunnel Rotterdam, with corroded bottom slab reinforcement, by the NLFEM program ATENA

In the river Maas, the tunnel floor has to carry a maximum upward water pressure of 18 meters, and there was sever doubt about the structural reliability of this floor in the corroded situation, given the observation that the cross section of a large number of the reinforcing bars was largely reduced as a result of chloride attack. The structural safety was investigated with different nonlinear FEM programs Fig. 14. The analyses were carried out in steps, assuming that an increasing part of the cross section of the reinforcing bars was reduced due to corrosion. The result of the analysis was remarkable. It was demonstrated that even if the cross section of the reinforcement of the slab would have been reduced to zero, the structural safety would still be sufficient. Fig. 14 shows the stresses calculated with the NLFEM program ATENA. It demonstrates the generation of concrete arches as a bearing mechanism, under the action of the water pressure in vertical and horizontal direction.
