HIGHWAY BRIDGES IN ONTARIO, CANADA: AVOIDING STRUCTURAL COLLAPSES THROUGH ASSESSMENT, MANAGEMENT, AND RESEARCH

Abstract: The main contribution to the corrosion of bridges in Canada is heavy use of de-icing salts, which can lead to severe rebar corrosion and girder soffit spalling in reinforced concrete (RC) highway bridge structures. Herein, recent challenges faced by authorities in dealing with corrosion problems in Canadian highway bridges are first discussed, and typical approaches for the assessment and management of these structures are described. A methodology to evaluate the residual strength of spalled RC bridges is then proposed. The basis for the proposed methodology is a modified area concept, which can be used to consider the effects of exposed reinforcement at various locations along the girder length. A multipoint analysis program is developed that employs this concept, along with graphical spalling surveys and structural drawings, to evaluate RC bridge girders. The program is then adapted for a full bridge analysis and to consider other effects of corrosion, such as bar section loss and bond deterioration. A case study bridge is evaluated to show that the developed

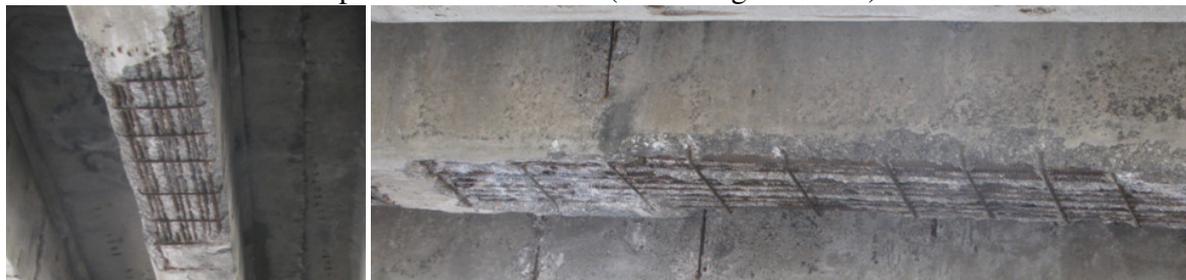
Fig. 1. Highway bridge girder soffit spalling

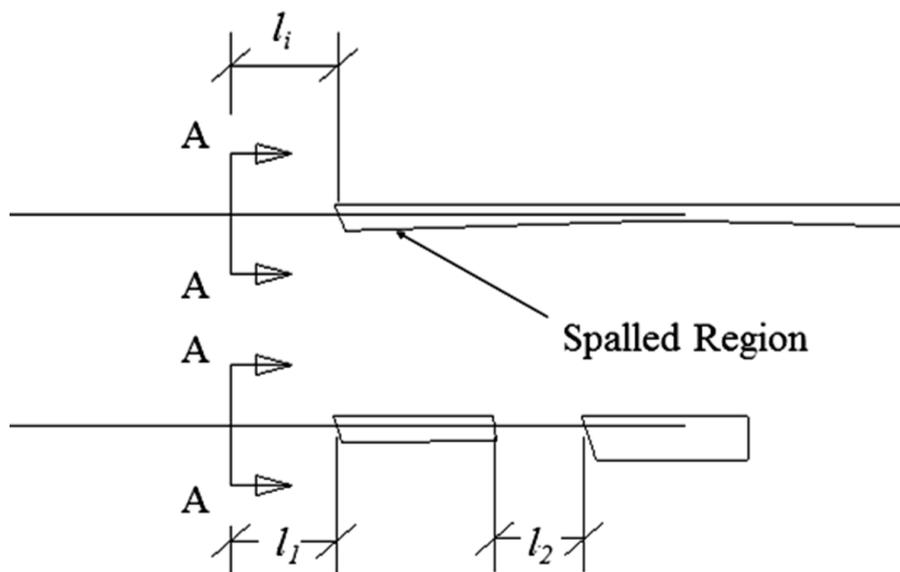
A reinforcing bar's cross sectional area is modified to model the reduced strength if its development length is compromised as illustrated in Figure 2. The modified area concept is founded on the following assumptions:

the reinforcing bar. At Section 'A' the intact development length is l_i . If multiple spalled regions are present, then the intact length is computed as the sum of each intact section. If the intact length is less than the required development length (i.e. $l_i < l_d$), then in the proposed concept the bar's cross sectional area is proportionally modified as follows:

Fsg. 2 Modified area concept

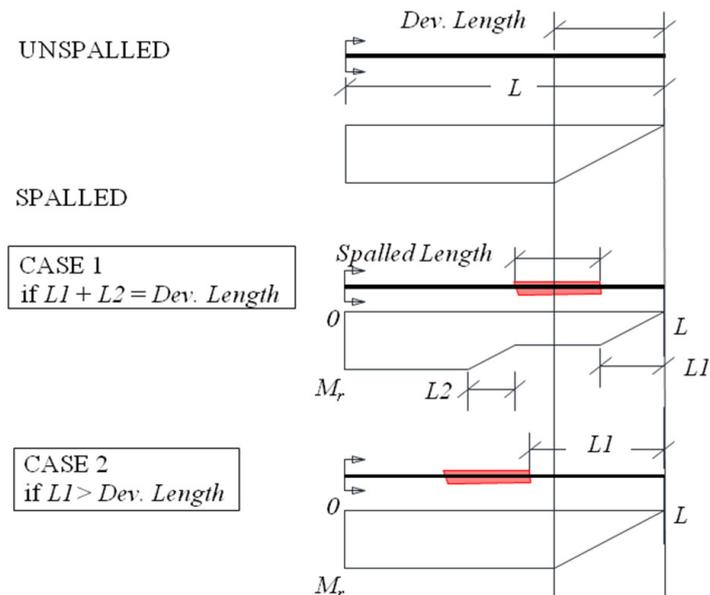
Fig.3 Moment resistance with unspalled and spalled bars

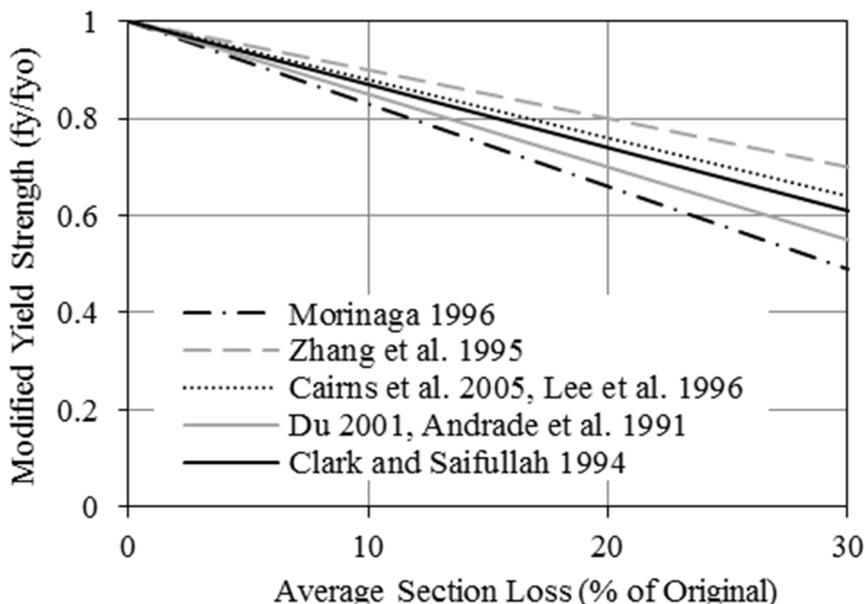
Fig. 4. Empirical models for residual yield strength of corroded rebar

Different values for α_y have been proposed by various researchers [9–15]. Figure 4 summarizes the results of a number of studies on α_y . In the current research, the curve proposed in Cairns et al. 2005 [9] has been used.

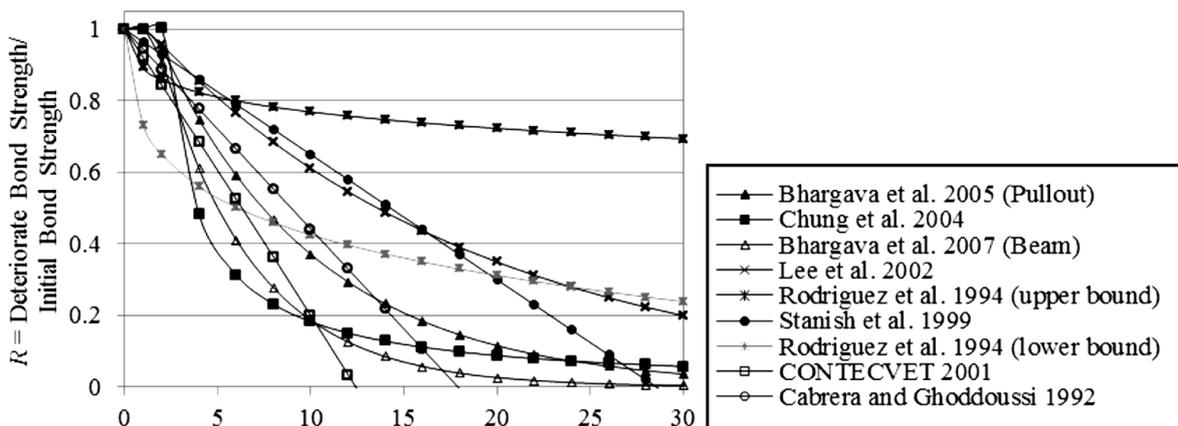
Fig. 5. Empirical models for steel-concrete bond deterioration

Several researchers have suggested empirical formulations for predicting the bond strength of corroded rebar [16-21]. The comparison of the models is shown graphically in Figure 5. Input for the bond degradation model comparison is as follows: longitudinal bar diameter = 31.8 mm, concrete cover = 50.8 mm, development (l_d) = 36.2 mm, concrete strength, (f_c') = 20 MPa,

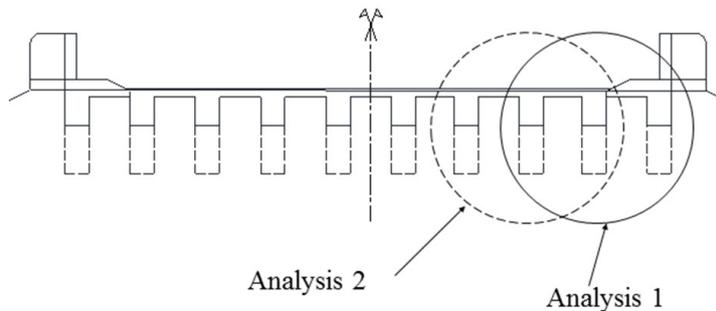
Fig. 6. Girder grouping for full structure analysis.

For a full bridge analysis, the effects of redundancy must be considered. In this model, it is proposed that for each group of three girders, the two remaining girders are assumed to carry the tributary load acting on all three girders, once a single girder fails (assuming that the deck can span between the two good girders). The overall capacity of the structure is then estimated by evaluating groups of three girders in succession with the bridge capacity limited by the lowest capacity of any of the girder groups.

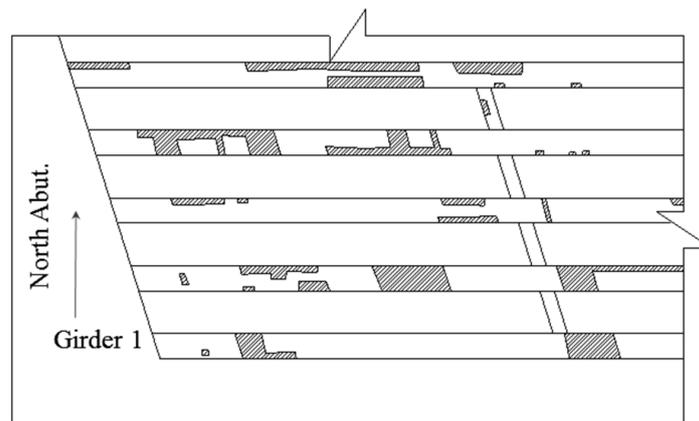
Fig. 7 Spalling survey sample

In the first step a sectional analysis of a single girder is performed at several predetermined cross-sectional locations (100 in this case). At each location, the flexural and shear capacities are calculated. The spalling surveys and reinforcing plans are used as the primary sources of BEST program input. Spalling surveys are created in Ontario to document deterioration by the Ministry of Transport Ontario (MTO), generally after field scaling procedures are carried

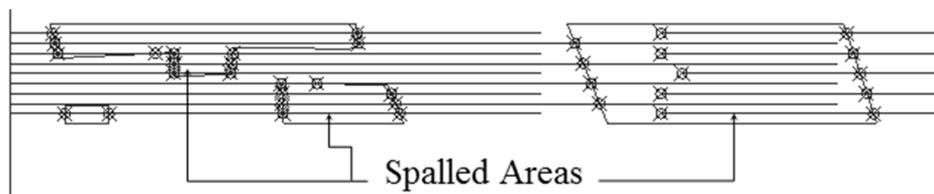
Fig. 8. Reinforcement plan-spalling survey superposition

out to remove loose concrete (see Figure 7). In Autocad [22], the reinforcement plan for the bottom lower reinforcement is then superimposed on the spalling survey for each girder. Points are added to all locations where this reinforcement intersects the spalled regions. Sample input for this step is shown in Figure 8. The data extraction function is then used to create point and line data text files that became the input for the Matlab [23] program.

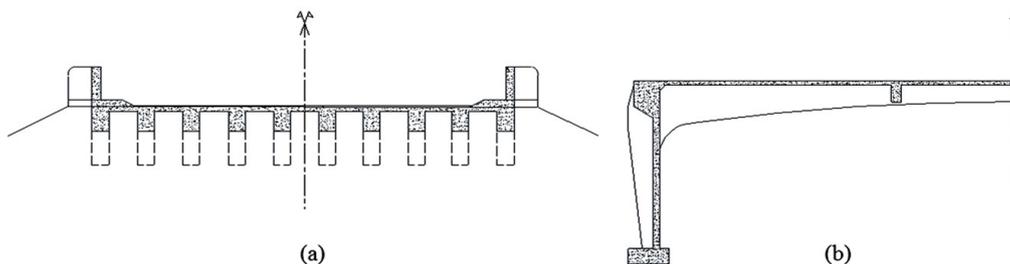
Fig 9. Bridge cross section and elevation

The case study structure was built in 1960 s. It represents a common structural configuration on many major Canadian highways: a rigid frame bridge with a gently arched girder shape (Figure 9). Severe spalling and delamination of the girder soffits, shown in Figure 1, poses the greatest threat to the ultimate strength of the structure.

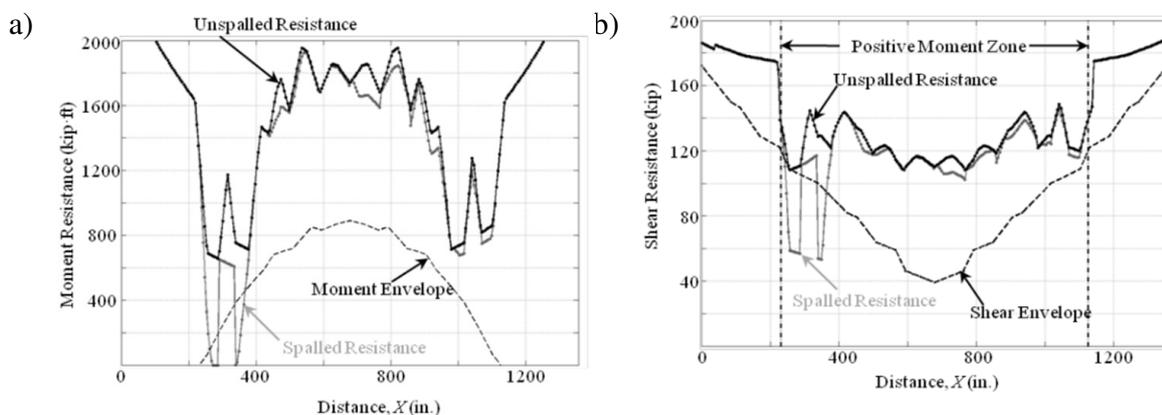
Fig 10. Strength evaluation of case study girder: (a) flexure (b) shear (general method)

The developed program provides graphical output that compares the residual resistance (flexure or shear) to user-defined load effect envelopes. Figure 8 shows samples of the graphical output for the flexural and shear analysis of a single girder in the case study structure. The load effects are shown as dashed lines and indicate the envelope of the maximum moment due to the CL-625-ONT truck (CAN/CSA S6-06) [8] located at any position of along the bridge span. This envelope was obtained using a model of the bridge girder created with the structural analysis software SAP 2000 (2009) [25]. The residual resistances are shown as solid lines.

In order to show the effects of anchorage loss only, the analysis presented in Figure 8 (and 8(a)) considers only the effect of spalling and loss of anchorage on the capacity of the structure; no corrosion effects are considered in Fig. 8. In these figures, the x-axis origin corresponds with the north girder support and extends to the south support at an x-coordinate of 34.47 m.

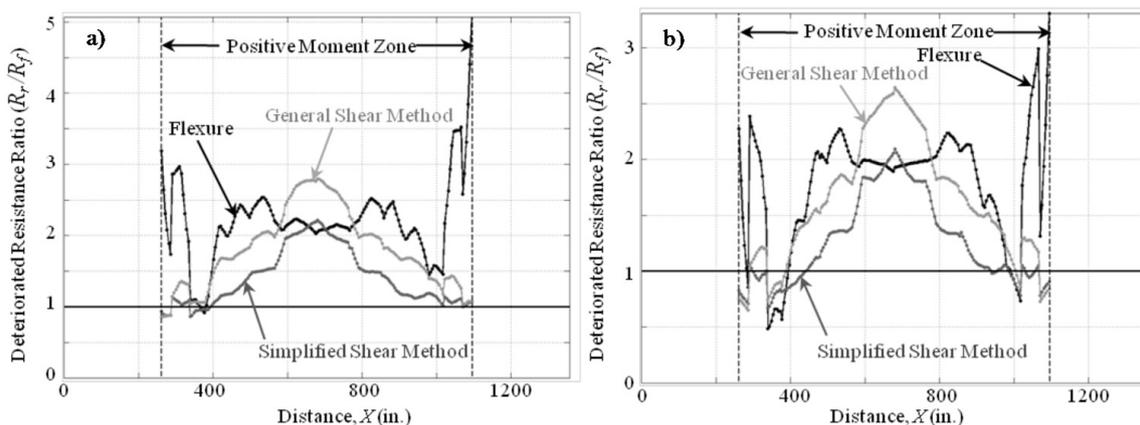
Fig. 11. Full structure analysis considering: (a) bond and development only, and (b) all deterioration effects

In Figure 11(a) the results of the full bridge analysis are plotted for the flexural, simplified and general shear method verifications.

Rebar section loss and bond deterioration effects are not considered in this figure. Each curve represents the minimum factored resistance-to-load effect ratio at each point along the span for all groups of adjacent girders analyzed. Although these curves still drop below 1.0 at some locations along the span (indicating that the structure fails at these locations), the benefits of considering system behaviour are apparent. Assumptions of 15% corrosion within spalled

sections and 6% corrosion in intact concrete were made for the purpose of demonstrating the effects of incorporating the rebar section loss and bond deterioration models. The impact of these assumptions can be seen by comparing Figs. 11(a) and (b). In Fig. 11(b), the resistance ratio at the worst section is now considerably less than 1.0.

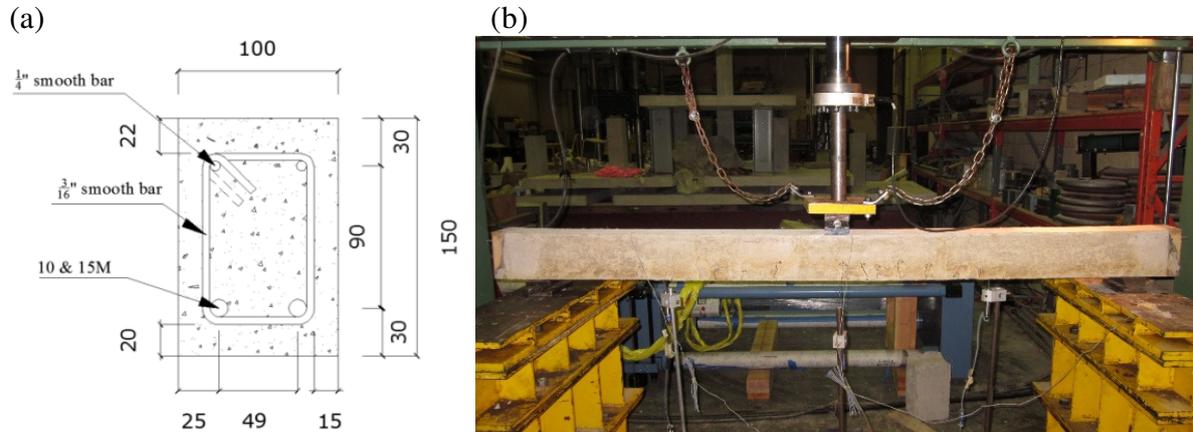
Fig. 12. Beam specimens: (a) cross-section, and (b) control beam during three-point bending test

The loss of bond was simulated by surrounding the longitudinal reinforcement with styro-foam prior to pouring the concrete (see Figures 12(a) and (b)). The beams were simply supported and loaded centrally by a point load. Stirrups were placed to protect against potential shear failures (Figure 12(c)) at a spacing of 190 mm. The results of testing of seven beams of dimensions of 2100×150×100 mm, with simple supports at 1900 mm distance, are presented herein.

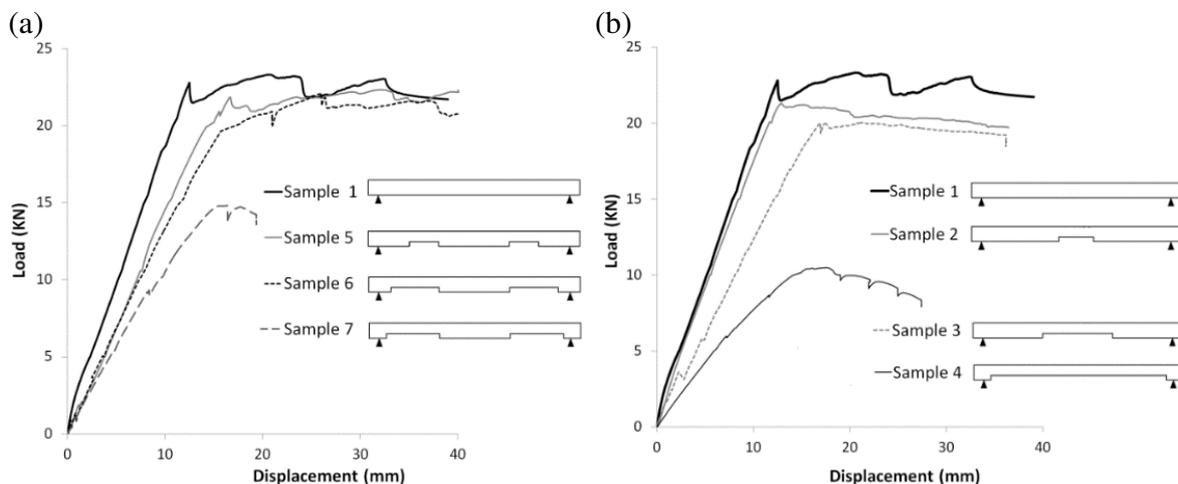
Figure 13: Load-Deflection Curves for the Tested Beam Specimens

The beam was tested at a load rate of 0.03 kN/s. Loading continued until complete failure of the specimen. The beam deflection was recorded by linear variable differential transformer (LVDT) at 2 s intervals. Load-deflection curves for beam Samples 1–7 are shown in Figure 13.

Specimens 1, 2, 3, and 4 were made with exposed regions at the midspan with increasing exposure areas up to 85%, resulting in a 55% reduction in strength (see Figure 13 and 14). Specimens 1, 5, 6, and 7 have exposed regions near the supports (in the anchorage and flexural zones). Specimen 7 has the largest strength reduction with a strength that is only 36% that of the control specimen.

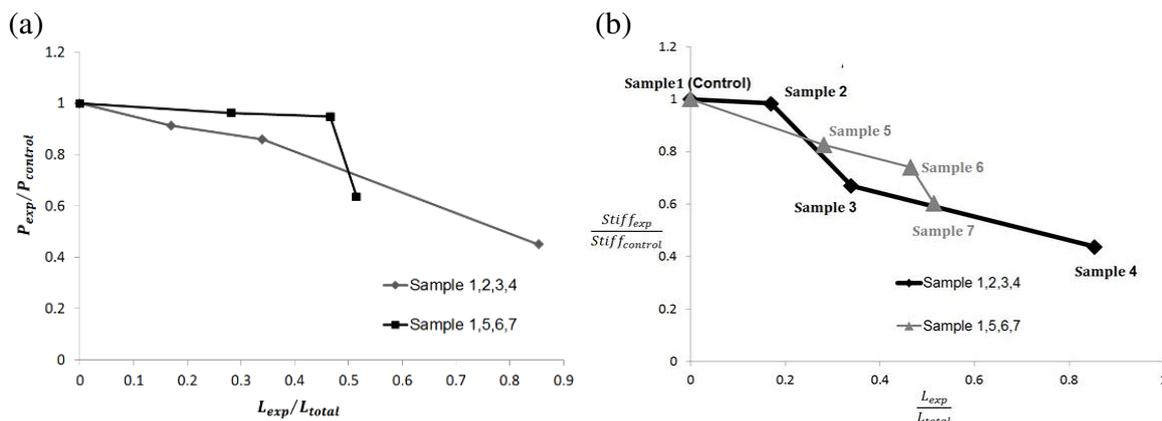
Figure 14: Effect of exposure length on a) beam strength, and b) beam stiffness

Figure 14(b) presents normalized outputs from the test showing a relationship between $Stiff_{exp} / Stiff_{control}$ and L_{exp} / L_{total} , where: $Stiff_{exp}$ is the initial flexural stiffness of the sample with exposed reinforcing, $Stiff_{control}$ is the corresponding flexural stiffness for the control sample, and L_{exp} and L_{total} refer to the exposed and total beam length. In this figure, the stiffness was calculated using the load-displacement data up to 80% yield load. As shown in this figure, the

stiffness of the beams was not affected significantly if the length of exposure is limited to less than 20% of the total length. Generally speaking, the data for Specimens 1–7 suggests that the stiffness reduces with an increase in exposure length.
