Kansai University, Osaka, Japan

Kinki Regional Development Bureau, Ministry of Land, Infrastructure and Transport, Osaka, Japan

EFFECT OF REINFORCING METHOD AGAINST FATIGUE CRACKING OF ORTHOTROPIC STEEL DECK WITH BULB RIBS

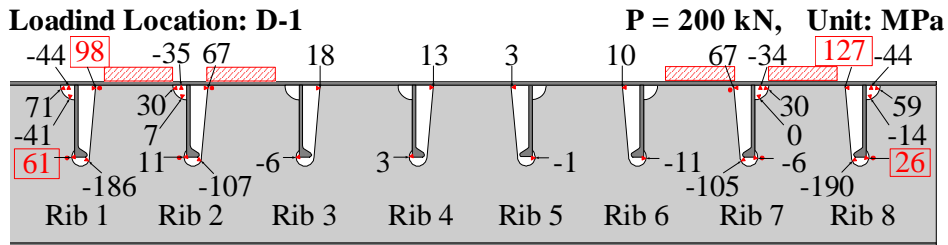
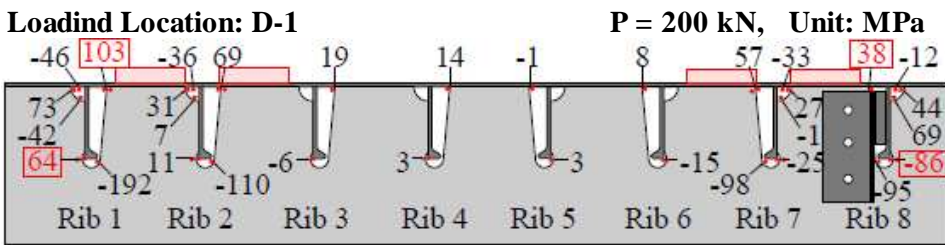
Figure 5. Result of static loading test

Figure 5 shows the results of the static loading test, both with and without reinforcing. As shown in Figure 6, both stresses at both the upper part(⑥) and lower part(④) of the Rib 1 and Rib 8 slits were tensile stresses, and the stress at the upper part(⑥) of the slit is higher than that at its lower part(④). The stress at the upper part(⑥) of the Rib 8 slit was higher than that for Rib 1. Therefore, we reinforced the intersection of Rib 8. After applying angle steel reinforcement, the stress at the upper part(⑥) of the Rib 8 slit decreased to approximately 30% (from 127 MPa to 38 MPa), and the stress of the lower part(④) of the Rib 8 slit changed from a 26 MPa tensile stress to a 86 MPa compressive stress. The stress at the upper and lower parts of the Rib 1 slit did not change.

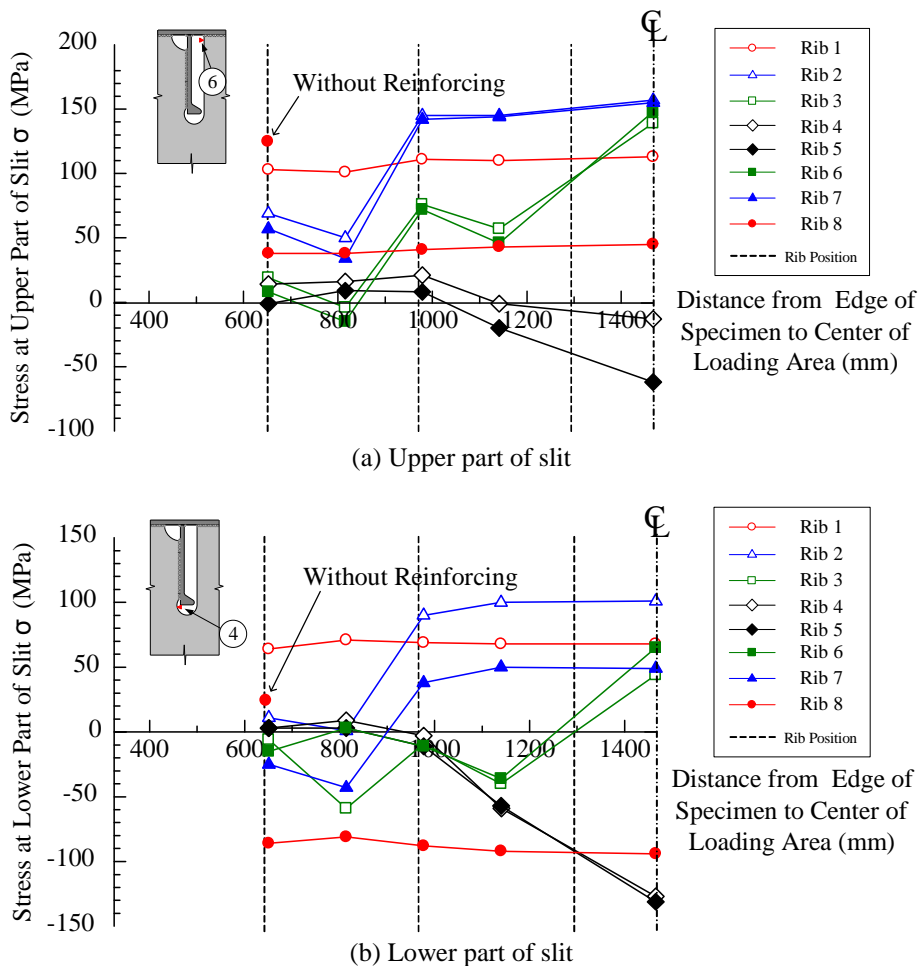
Figure 6. Stress at intersection of bulb rib and transverse rib (P=200kN)

Figure 6 shows stress at the intersection of the bulb rib and the transverse rib. The stresses at the slit of Rib 1 and Rib 8 were almost constant. As loading the slit side, the tensile stresses at Rib 2, Rib 3, Rib 6 and Rib 7 slits increased. On Rib 4 and Rib 5, however, the compressive stresses of Rib4 and Rib5 slits increased. Also, we found that the tensile stress at the upper part of the slit is higher than that at its lower part.

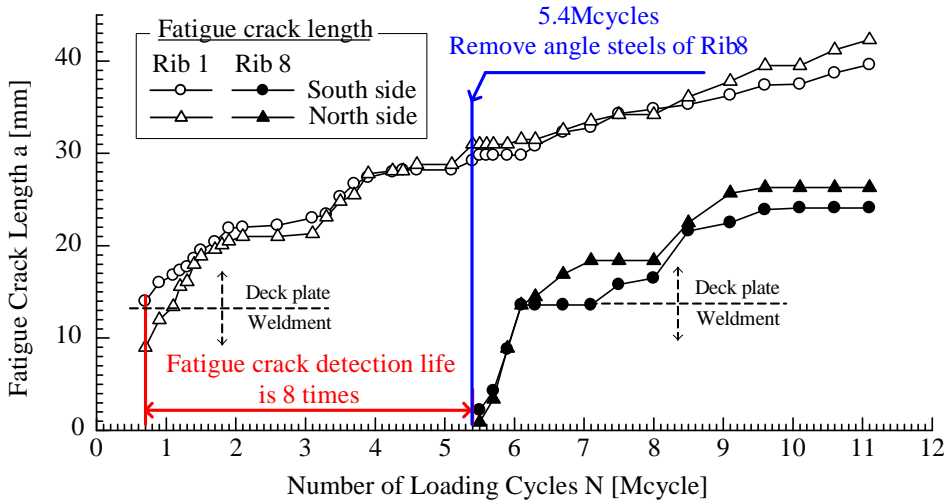
Figure 7. Relationship between fatigue crack length and the number of loading cycles

Figure 7 shows the relationship between the fatigue crack length and the number of loading cycles. The vertical axis represents the fatigue crack length, while the horizontal axis represents the number of loading cycles. Fatigue cracks of Rib 1 and Rib 8 continued to propagate slowly after propagating into the deck plate. After 11.1 Mcycles loading, the fatigue cracks of Rib 1 and Rib 8 propagated to about 40 mm and 25 mm length, respectively, but they did not propagate to the upper surface of the deck plate. Photo 5 and 6 show the fatigue cracks
