Piotr D. Moncarz*, moncarz@exponent.com

DELAMINATION IN A PRESTRESSED CONCRETE WALL – A MULTI-BILLION DOLLAR DISTRESS IN A NUCLEAR POWER PLANT

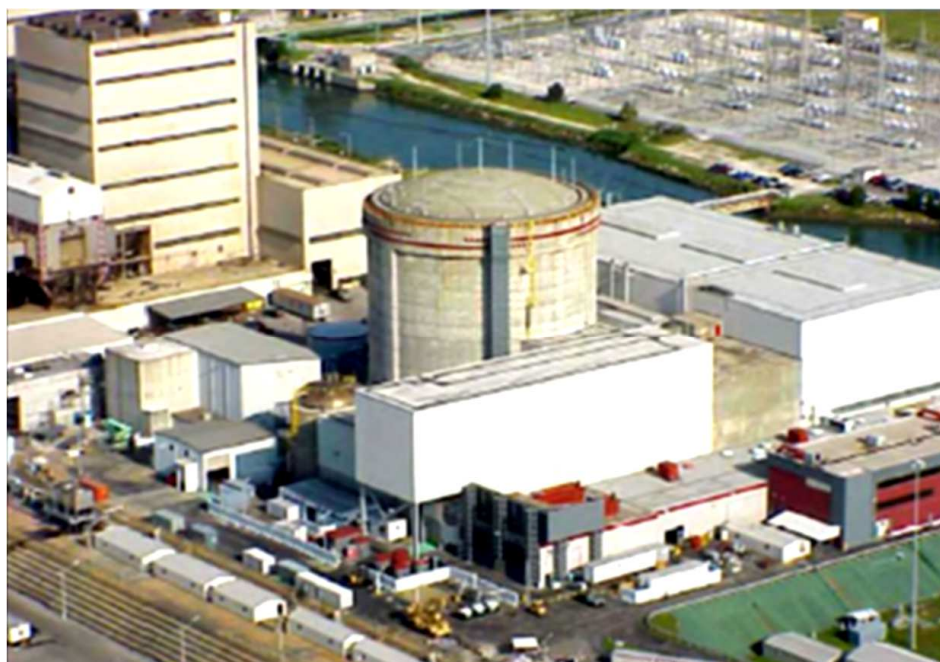
The 860 MWe pressurized water reactor (Figure 1) started commercial operation in 1977. In 2009 a refueling operation started which included the replacement of the two steam generators located inside the containment structure. The reactor system is housed inside a secondary containment structure providing safety in case of accidental heat and/or pressure releases from the reactor system. The Steam Generators are also located inside the containment.

Figure 1. Overall site view.
