TECHNICAL CAUSES OF THE COLLAPSE OF DE LA CONCORDE OVERPASS IN LAVAL, CANADA

BENOIT BISSONNETTE, *benoit.bissonnette@gci.ulaval.ca*
Research Center on Concrete Infrastructure (CRIB)
Dept. of Civil Engineering, Laval University, Quebec City (QC), Canada

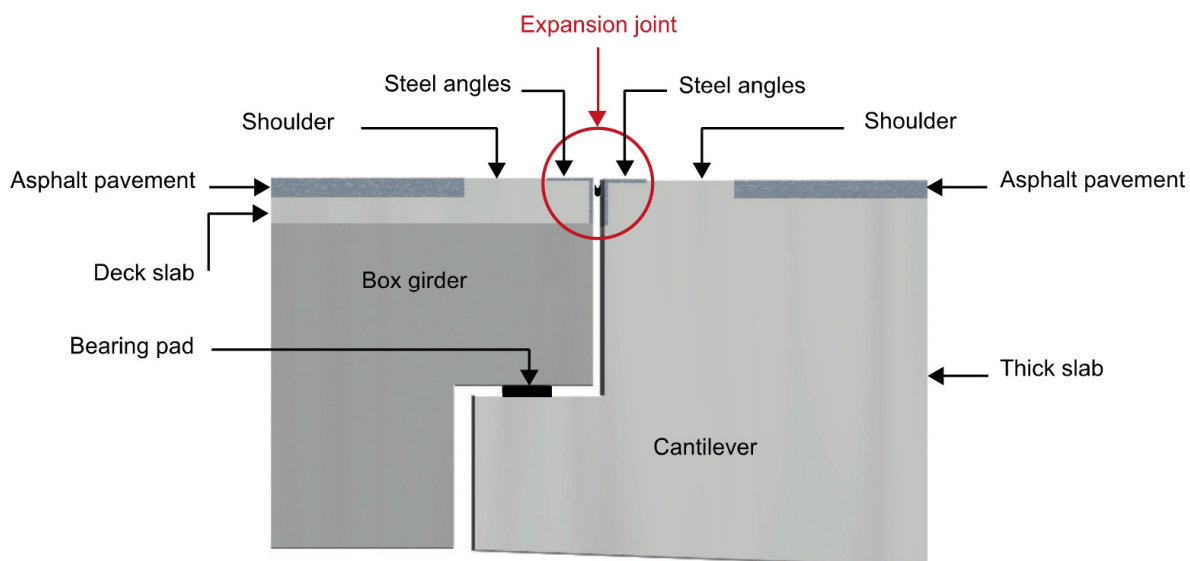
The box-girder deck rested on beam seats located at the end of the cantilevers and continuous across the full width of the bridge, directly under the expansion joints (Fig. 2). The end of the cantilever is a particularly complex load transfer area. The expansion joints are severely exposed elements that lose their ability to evacuate water when damaged, contributing to the accumulation of moisture, deicing salts and debris on the load-bearing support. The vulnerability was even greater in the present case because the seats could not be inspected and maintained without lifting the deck. To do so, traffic would have had to be interrupted on both Boulevard de la Concorde and Highway 19. The expansion joints and the ends of the cantilevers on this type of structure thereby become critical areas requiring special attention during inspections and maintenance work.

Fig. 2. Diagram illustrating the cantilever beam seat configuration
